CATCH CONTROL IN THE BLUE WHITING PELAGIC TRAWL FISHERY

Research Cruise Report [2022825]: FV "Vikingbank"

TOKTRAPPORT
No.1 2023

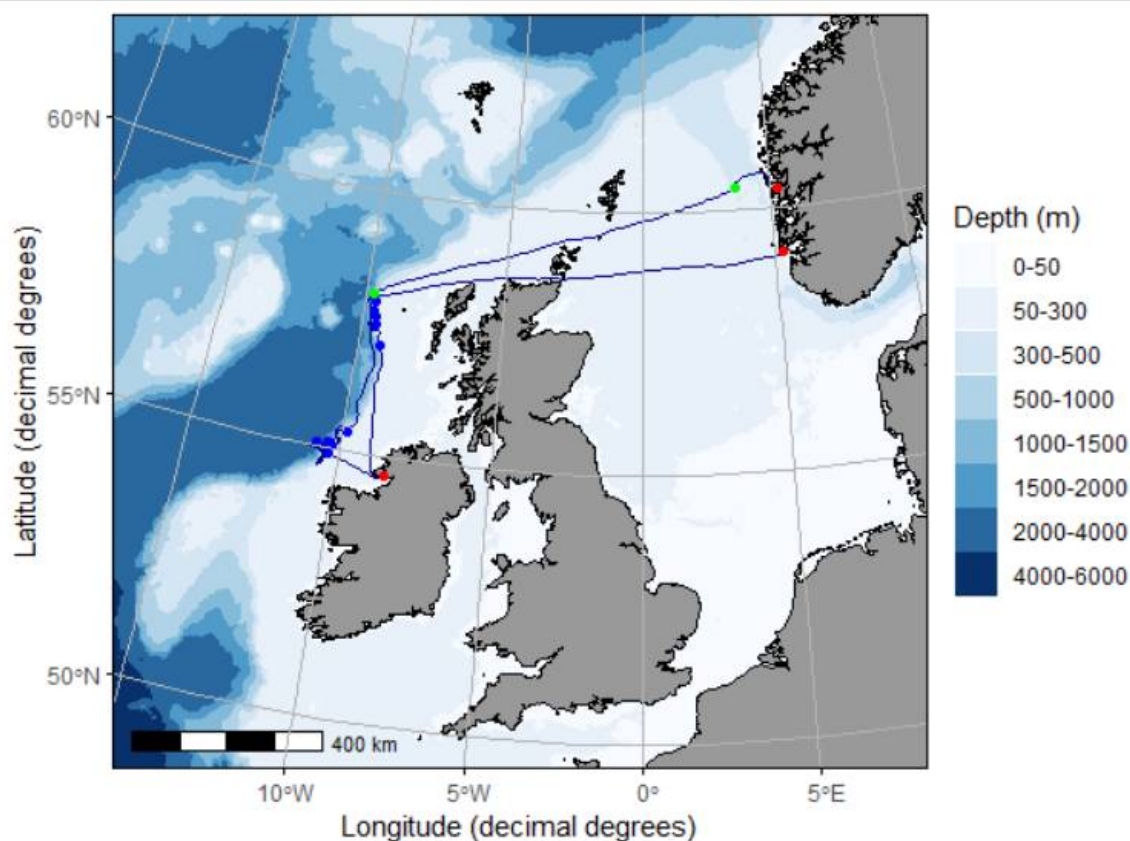
Figure 2.1 – Chart of cruise track (dark blue line), test hauls (green points), fishing hauls (blue points) and harbours visited (Bergen, Norway; Killybegs, Ireland; Skudeneshamn, Norway; red points). Details of the times and detailed positions of the test and fishing hauls can be found in table 2.1.

There were thirteen hauls taken during the cruise: 2 test-hauls (without targeting catch) and 11 specifically targeting blue whiting (Figure 2.1 and Table 2.1). The first test-haul was conducted in deep water off the Norwegian coast [60.43N, 3.24E at 20:00], with the aim of checking the trawl and catch control and bycatch release sections were correctly rigged, as well as fitting depth sensors (section 9) and testing the cod-end choking unit (section 5). A second test haul was conducted in deep water at the continental shelf edge, WNW of St. Kilda [58.02N, -9.72W at 1335], to further practice camera fitting methods and positioning, in preparation for “live hauls” targeting blue whiting schools. We then sailed south towards the Porcupine Bank fishing grounds, entering the Irish/EU zone at 04:30 [56.69N -9.32W] on 26th March.

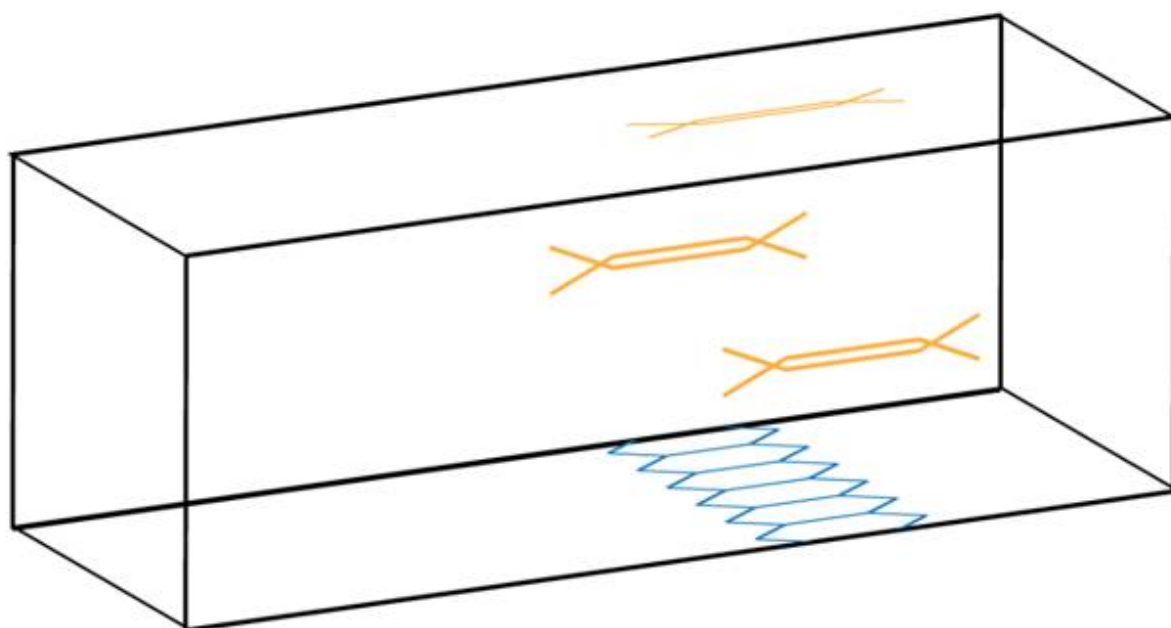
Figure 3.2 – Above: schematic diagram of 16m long fish release section (FRS) with 2.5m long slots on each of top and side panels and 2.7m Hexagonal Meshes in the bottom panel; for a detailed net drawing see appendix C.

The fish release section (FRS) used during this cruise consisted of a four-panel cylinder of netting, approximately 16m long, inserted between the trawl and cod-end, that incorporated two types of escape openings: 2.5m long slots on each of top and side panels and 2.7m Hexagonal Meshes in the bottom panel (figures 3.1 & 3.2). The distance from the openings to the cod-end was 6 m. The theoretical area of release openings: 18.9 m². The rig should allow free passage of the catch from the trawl into the cod-end during the fishing process, until the cod-end is full. The escape openings therefore should prevent escape during the normal fishing process, but once the cod-end is full should then enable fish to escape freely with minimal risk of crowding and abrasive injury.

When fitted to the trawl, the FRS appeared to be stable and adopt its designed geometry. The only exception was during the test hauls and hauls 01 and 07, when the bycatch release section (BRS) was attached. During these hauls it was noted that the vertical opening of the CLS during fishing was reduced by ~20% from ~2.5m to ~2.0m (table 2.2b).

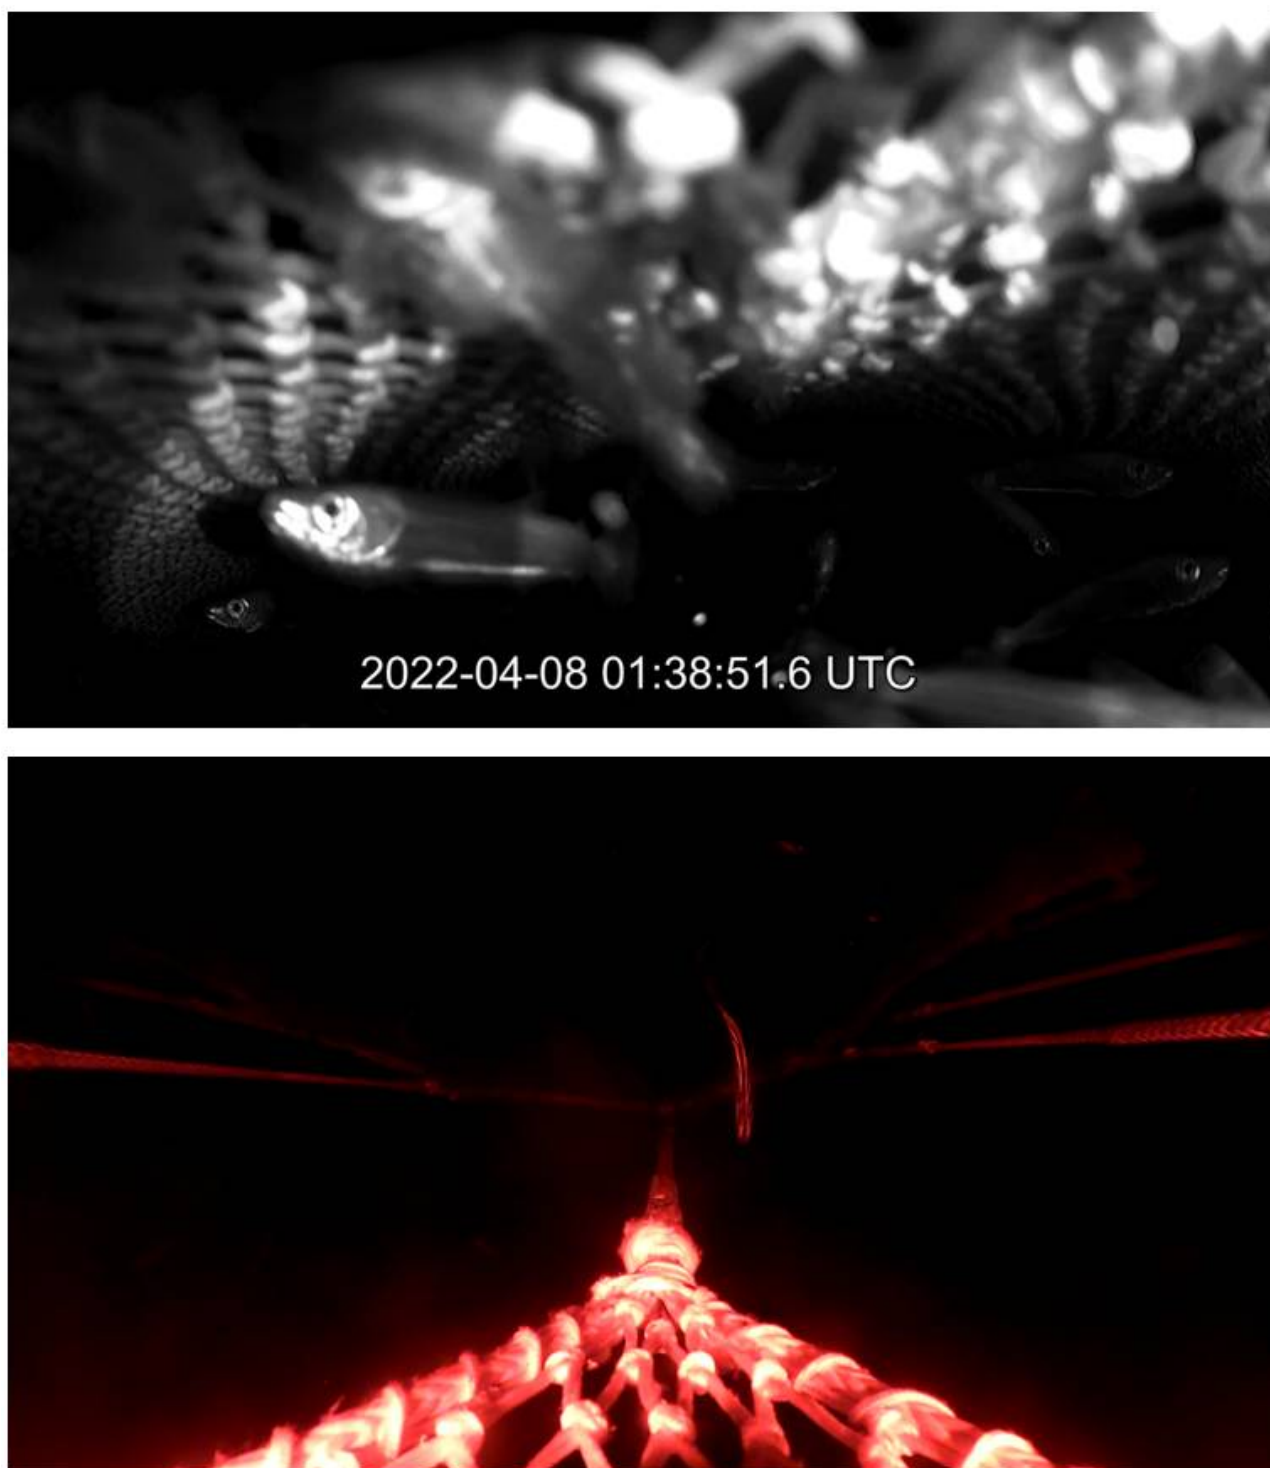
Figure 3.3 – Images from video taken during haul 11 at 01:38, just before the start of haul-back at 01:39. Top: from position 5iB looking aft toward the fish-lock and cod-end, showing medium densities of fish in the top of the FRS. Bottom: from position 4iB, looking aft over the escape opening, toward the fish-lock and cod-end, with three fish escaping. Note – the escape rate was approximately 12 fish/minute [01:38-01:39].

species through the release opening in the bottom panel. At low to medium densities in the upper part of the FRS, which were the most prominent catch densities observed, the typical escape rate was 0 to 15 fish per minute (figure 3.3). While at high densities, escape rates of between 23 and 65 fish per minute were observed (figures 3.4 & 3.5).

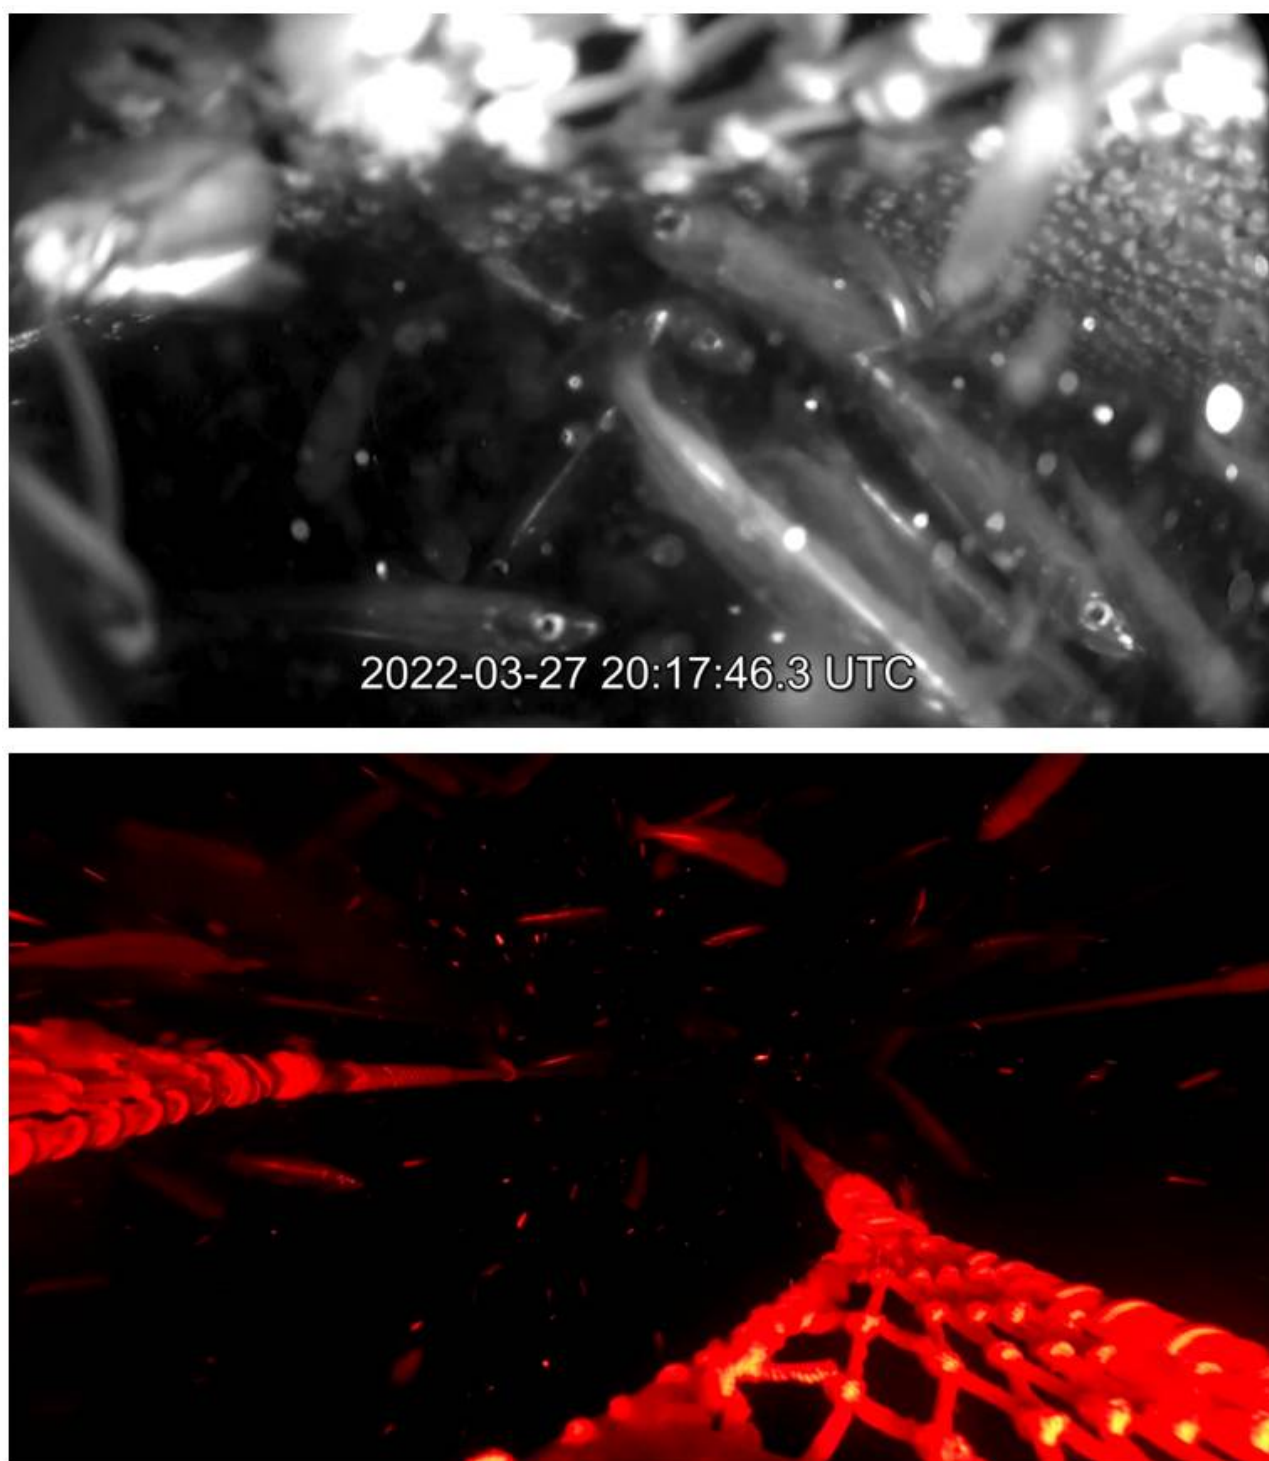
Figure 3.5 – Images from video taken during haul 03 at 20:17, 16 minutes before the start of haul-back at 20:33. Top: from position 5iB looking aft toward the fish-lock and cod-end, showing high densities of fish in the top of the FRS. Bottom: from position 2iF, looking forward over the escape opening, with medium densities of fish passing over the escaping open. Note – the escape rate was approximately 65 fish/minute [20:17 - 20:18].

Throughout all of the reviewed video observations, there was a consistent behaviour pattern in the target species, blue whiting; they generally congregated in the upper part of the FRS as they passed through. For the majority of time, densities in the upper part of the FRS were low to medium, with only very low densities of fish seen passing over the large hexagonal opening in the bottom panel (e.g. figure 3.3). However, when high densities were observed in the upper part of the FRS, there was a proportional increase in density in the lower part (e.g. figures 3.4 & 3.5).

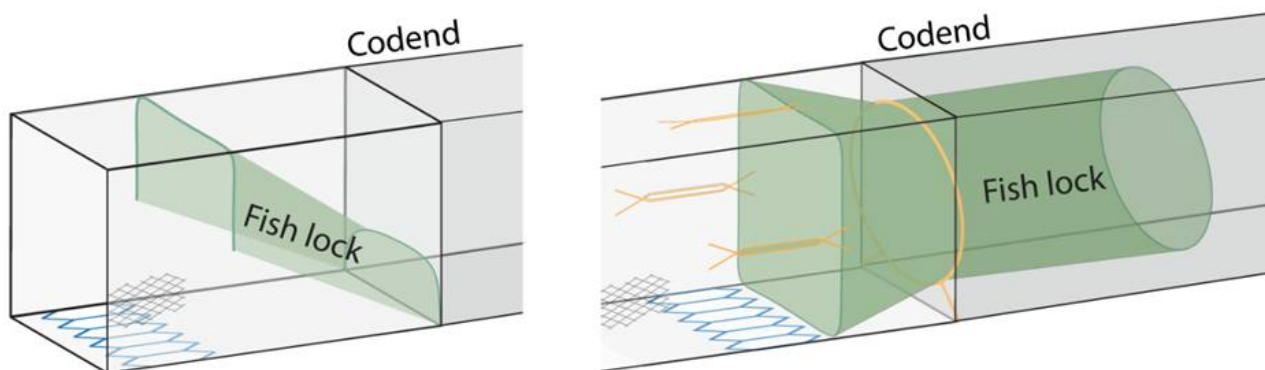
Figure 4.1 – Schematic diagrams of fish lock designs: Left – type 1, panel; Right – type 2, cylinder.

Two different “fish-lock” designs were tested during cruises 1 and 2. Type 1 was constructed of a netting panel 80 mm mesh size with 210/96 nylon (PA) twine, 74.5 meshes long (6 m). This was fixed to the top panel, approximately 0.3 m to the aft of the escape opening, and then fixed on a diagonal line down to about halfway down the side panels (and toward the cod-end). The operation of this design (type 1) was observed during cruise 1 and is described in Breen et al (2021). In summary, when water flow in the codend reduced during haulback, the lower/aft portion of the panel dropped to the bottom side of the codend preventing fish from escaping forward.

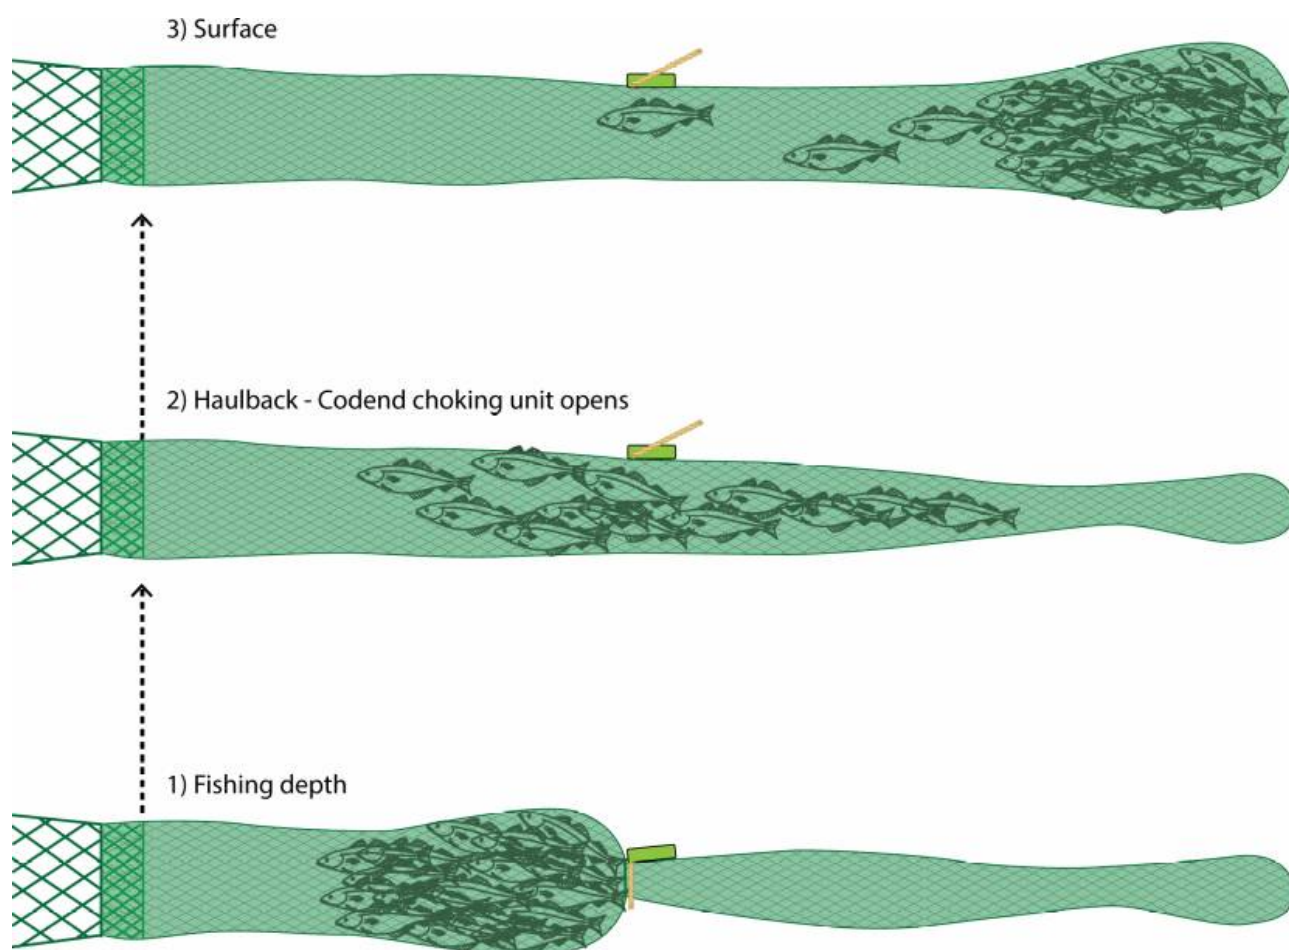
Figure 5.1 – Schematic diagram of the Cod-end choking unit in operation. 1: catch is retained in the cod-end ahead of the closed CCU; 2: the trigger depth is reached and the CCU opens; and 3: the retained catch dissipates into the residual component of the cod-end [Source: Ingolfsson et al, 2022].

The cod-end choking unit (CCU) is a prototype device (developed by FossTech AS) that can be placed at different locations along the length of the cod-end, to limit the effective volume of the cod-end and thus the volume of the retained catch (Ingolfsson et al, 2018; Breen et al, 2021). At a pre-determined depth (between 50 and 150m) during haul-back, the release mechanism opens allowing the restrictor-rope wrapped around the cod-end to release, which results in the retained catch moving (with the towing induced flow inside the trawl) into the residual cod-end (figure 5.1). If timed correctly, this transfer of the catch from the retaining cod-end into the residual cod-end should dissipate the catch over a larger volume within the cod-end. This will prevent the catch concentrating at the terminal end of the cod-end, which provides two key benefits: i) fish can freely decompress, evolving expanding gas from ruptured swim-bladders and body cavities during ascent; and ii) dissipate buoyant lift from the catch over a larger surface area in the ascending cod-end, thus increasing drag and reducing acceleration during ascent.

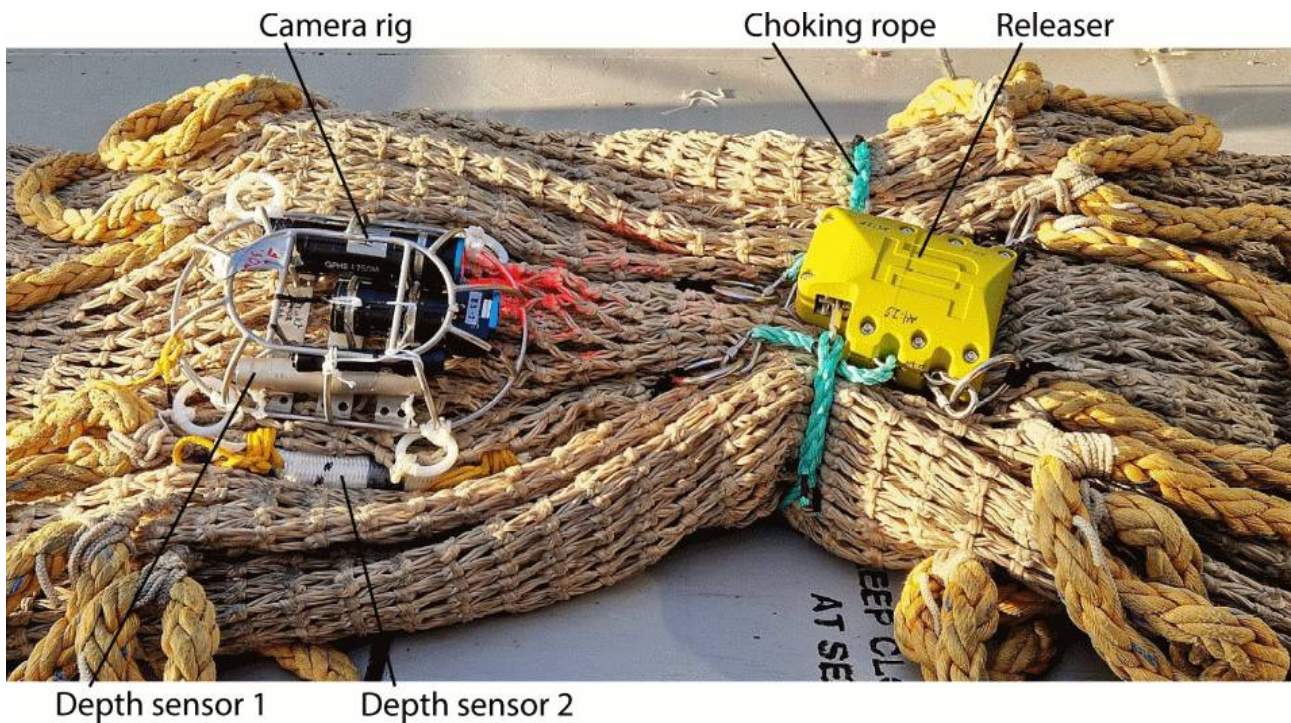
Figure 5.2: Haul A01, depth triggered cod-end choking unit (CCU) with a choking rope set at the 25m (~200t) position. Also shown is the camera and depth sensor assembly, in a protective steel frame, for monitoring the release depth of the CCU [Source: Ingolfsson et al, 2022].

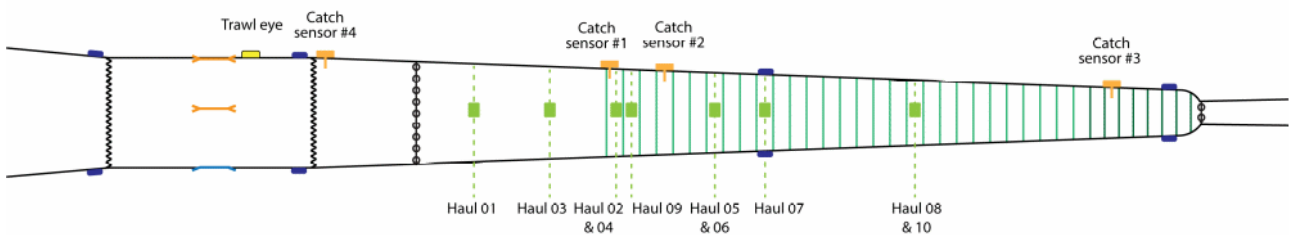
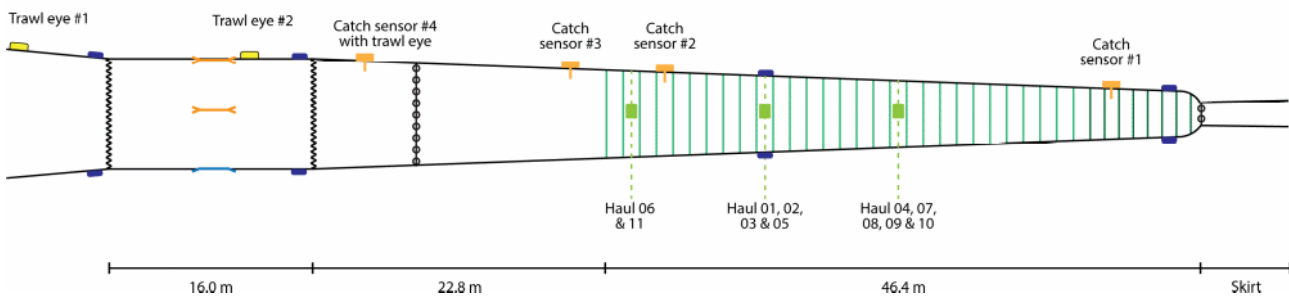
Figure 5.3 - positions on the cod-end of the Cod-end choking unit (CCU) and other instruments for cruise 1 (top) and cruise 2 (bottom). Releaser positions for each haul in both cruises are shown in green (see also table 5.2). Also shown are the relative positions of the “Trawl-Eye” echo-sounders (yellow), Catch Sensor units (orange) and depth-sensors (blue). [Source: Ingolfsson et al, 2022].

In addition to the CCU units, on haul A09 in cruise 1, a 10mm nylon constrictor rope (breaking strength ~2080 kg) was added to the cod-end at 23.22 m from the leading edge of the cod-end (between round-strops 1 and 2). This same method was used to reduce the risk of leakage through the choke point formed by the CCU restrictor line during cruise 2, in hauls B07 to B11, after a known leakage event in haul B06.

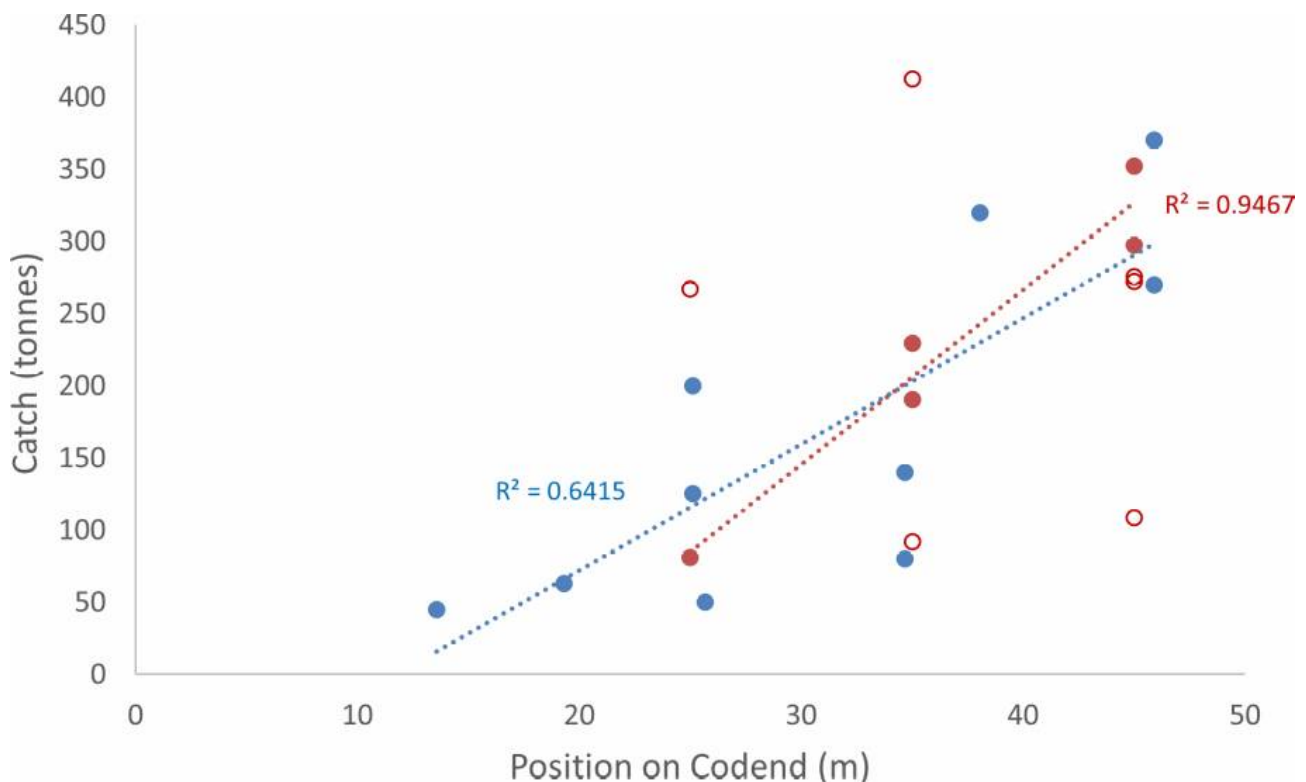
Figure 5.4 – The relationship between targeted catch size (tonnes) and the position (metres) of the CCU relative to the forward edge of the cod-end. Multiple linear regression analysis determined that catch size increased significantly the further aft the catch limitation releaser was positioned on the cod-end ($t = 5.41$; $p < 0.001$), while there was no significant difference between the relationships for either cruise ($t = -0.40$; $p = 0.699$). Blue dots show results from cruise 1 and red dots cruise 2. Open circles show hauls where problems with the releasers were experienced and are not included in the regression analysis. [Source: Ingolfsson et al, 2022].

There was a significant relationship between CCU position on the cod-end and the actual catch (in tonnes) ($t = 5.41$; $p < 0.001$) (figure 5.4). Furthermore, there was no significant difference in the relationship for either cruise ($t = -0.40$; $p = 0.6990$). The relationship for the valid hauls from cruise 2 was far more consistent than for the cruise 1 data (R^2 : 0.9467 and 0.6415, respectively), likely because known problems with catch control were deliberately removed from the dataset. Indeed, the spread of the invalid hauls (open circles in figure 5.4) are at least as variable as the cruise 1 data. This suggests that the higher variation in cruise 1 may be the result of catch leakage and prematurely terminated hauls, which were not appreciated at the time.

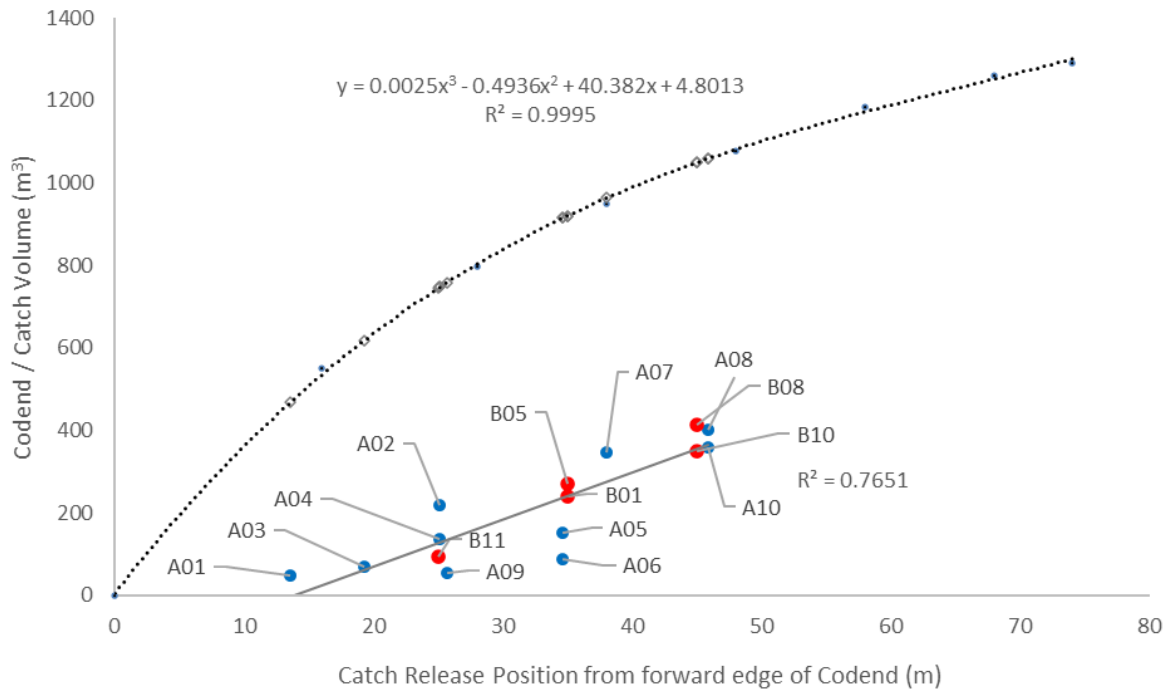
Figure 5.5 - The relationship between the position of the Catch Limit Releaser (CCU) and the resultant cod-end and catch volumes. Theoretical (third order polynomial; $R^2 = 0.9995$) cod-end volume estimates are shown in black, and theoretical volume calculated specifically for each haul as open grey diamonds. The resultant catch volume (m³) for each haul is shown for cruise 1 (blue) and cruise 2 (red), with a combined fitted linear relationship (black solid line; $R^2 = 0.7651$).

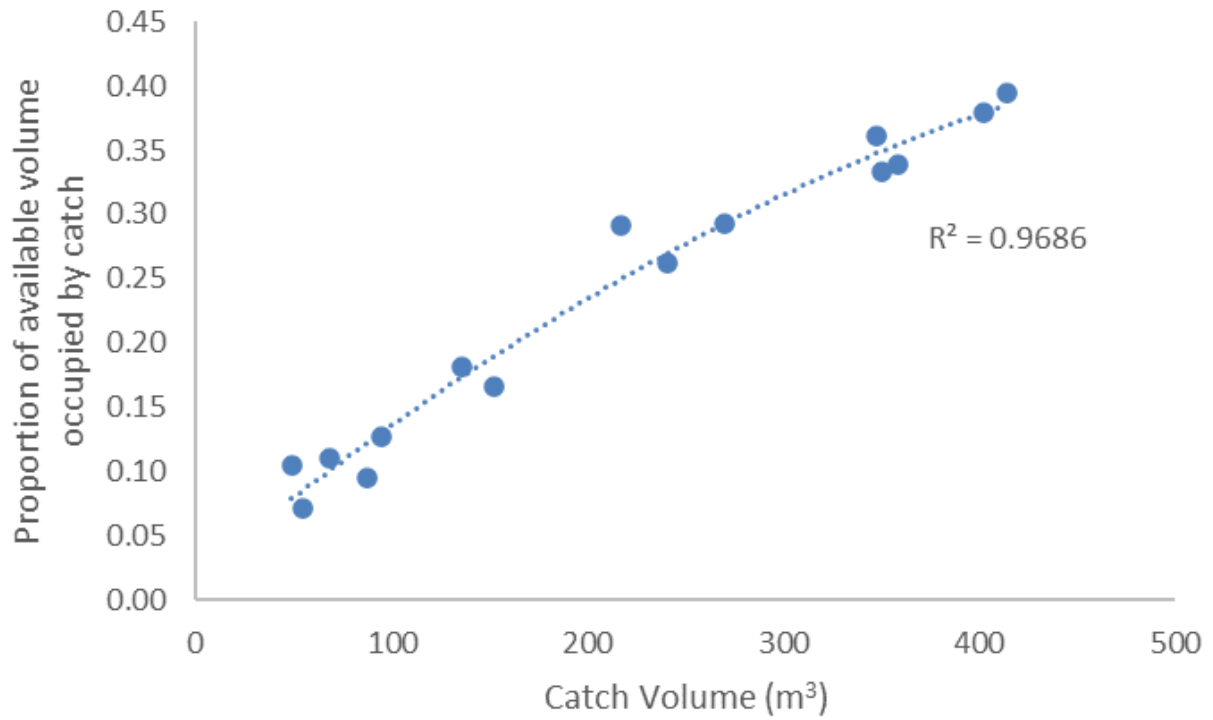
Figure 5.6 - The relationship between predetermined, empirical catch volume (m³) and the proportion of the theoretically available cod-end volume occupied by that catch increases significantly and consistently ($R^2 = 0.9686$) with increasing catch size. This suggests catch density in the cod-end also increases with increasing catch size.

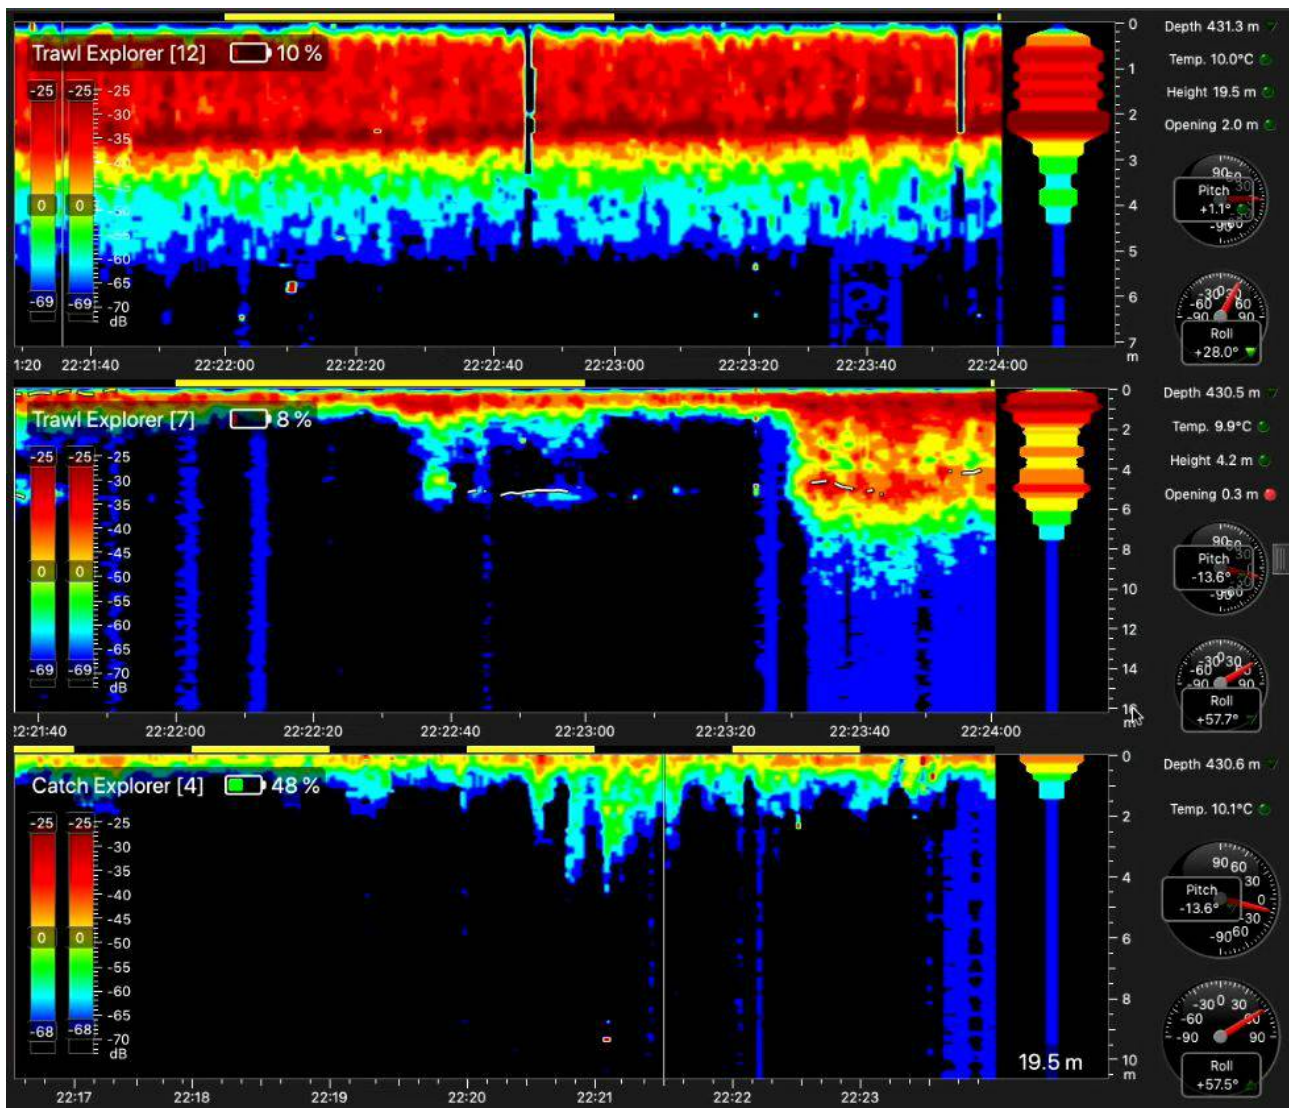
Figure 6.1 – Cod-end echo-sounder (CE_ES) echogram output from haul B05, just before haul-back began. Top: from forward of the FRS at CE-ES #1; Centre: from above the FRS at CE-ES #2; and Bottom: from behind the FRS at CS #4. CE-ES #1 shows high density accumulations of fish ahead of the FRS, while both CE-ES #2 CS #4 have periods where the densities are so high that the signal becomes occluded. These signals were confirmed by video camera (see figure 6.2).

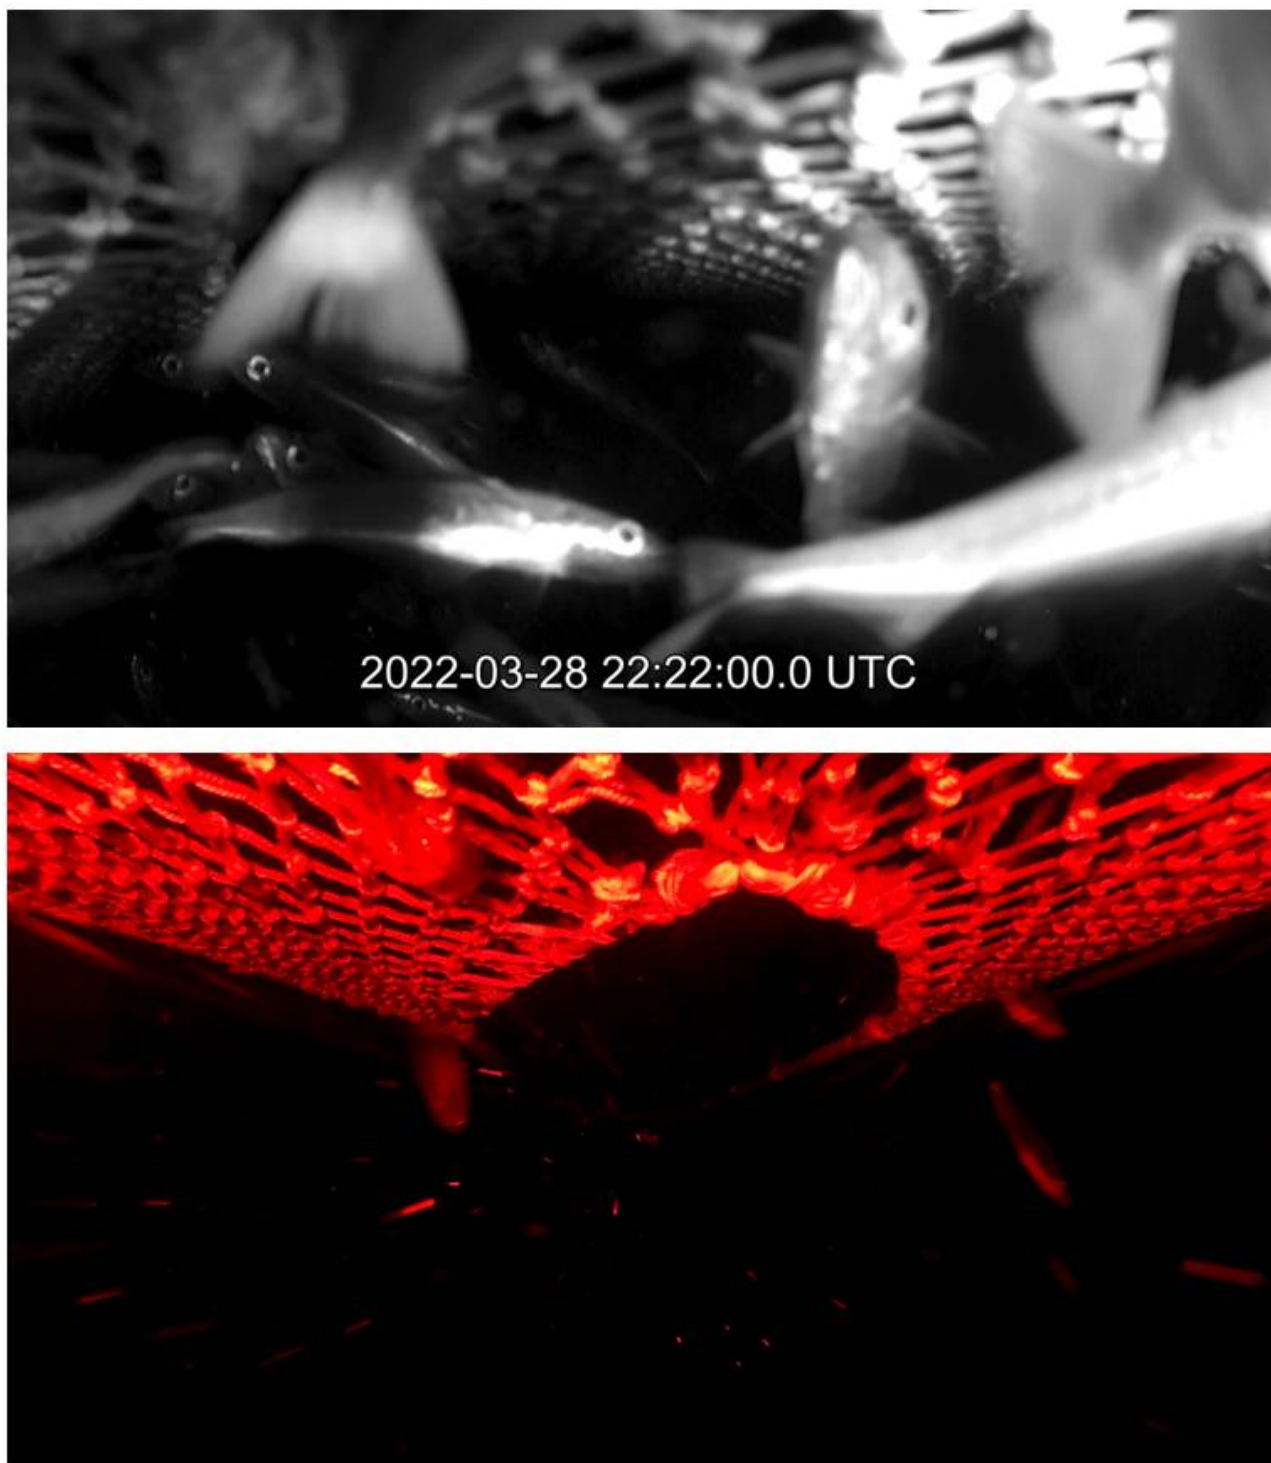
Figure 6.2 – Images from video taken at 22:22 during haul B05, just before the start of haul-back at 22:24. Top: from position 5B look aft toward the fish-lock and cod-end, showing high densities of fish in the top of the FRS. Bottom: from position 4F, looking forward below the escape opening, with three fish escaping. Note – the escape rate at this time was approximately 42 fish/minute [22:22-22:23] and 39 fish/minute [22:24-22:25].

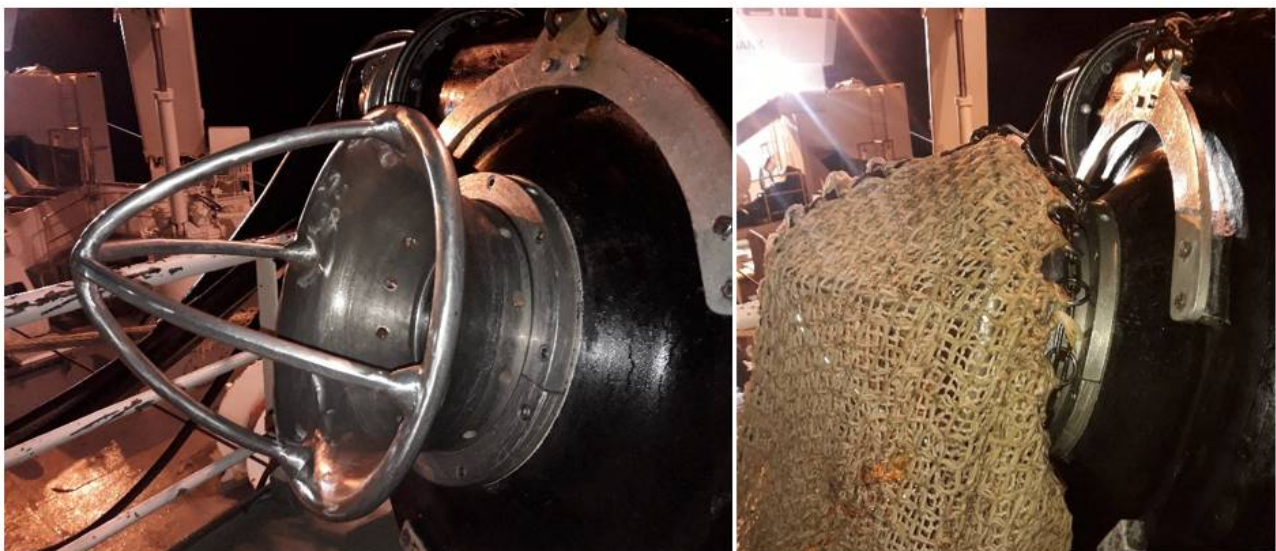
Figure 7.1 - Left: the pump-head funnel; and Right: pump with pump skirt connected [Source: J. Saltskår].

The most commonly used fish pumps by Norwegian fishing vessels are manufactured by Karm, Rapp Hydema and Seaquest. Current practice for coupling a pump-head to a cod-end is to use a chain (thickness 10mm; breaking strength 12 tonnes) wrapped around the cod-end skirt and pump-head funnel, and then locked with a shackle (figure 7.1). As a result, releasing the trawl cod-end from the fish pump on board the vessel can be time consuming, and can risk injury to the crew and damage to equipment. Unforeseen events during the pumping process can mean it takes a long time to empty the trawl cod-end. In the worst case, this can result in the catch losing buoyancy and the trawl cod-end sinking, with several hundred tonnes of fish inside. Such events can be extremely hazardous to the vessel and crew, as the safe working loads of deck equipment and cables can quickly be exceeded. To improve safety, as well as simplify the operation, the development of a quick-release coupling between the cod-end and pump has been proposed. This device should enable the remote release of the pump head from the cod-end skirt and should incorporate an auto-release function to ensure a safe-release when safe working loads are exceeded.

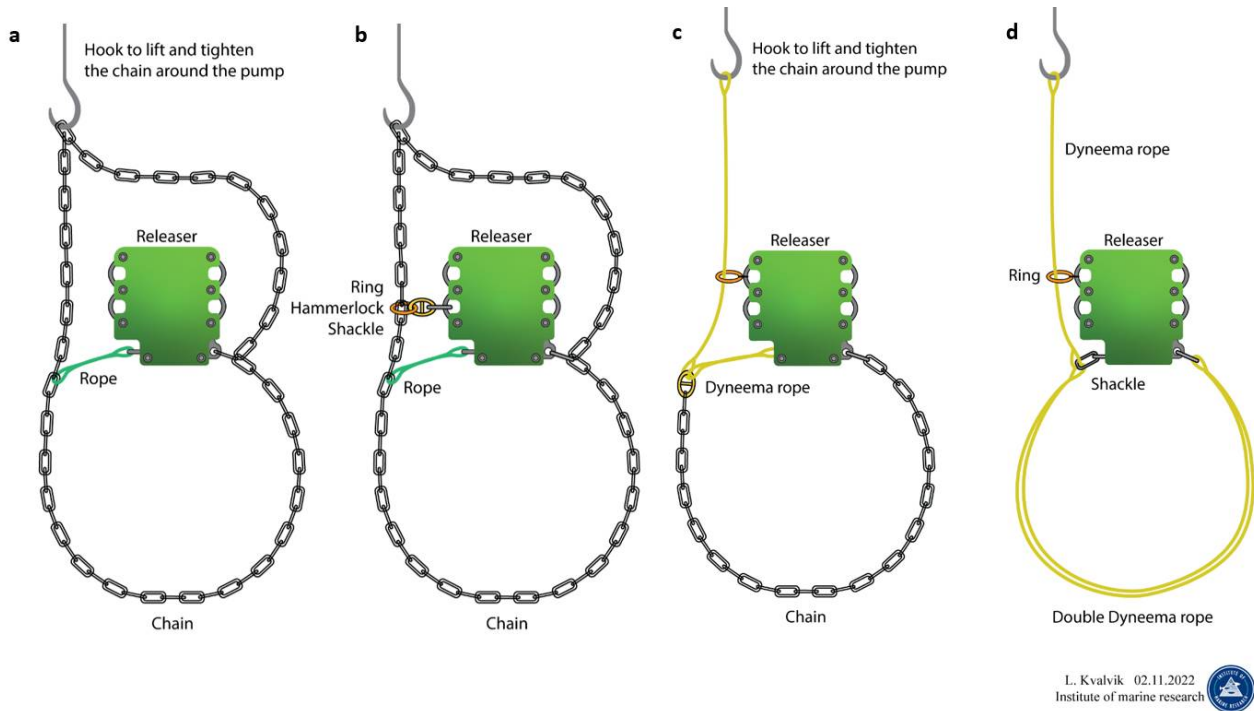
Figure 7.2: Schematic drawings of releaser with various rigs for securing the cod-end skirt to the pump-head. a: rig 1 used in tests A1, A2 & B1; b: rig 1a used in test B2; c: rig 2 used in tests C1 & C2; and d: rig 3 used in test C3.

Seven separate tests were conducted, using two different releasers (#1: A4:29; and #2: 9E:27) (table 7.1), with four different configurations of rigging securing the cod-end skirt to the pump-head (figure 7.2). During each test, the releaser and securing line/rig assembly was attached to the pump head and then lowered by crane into the water to a depth exceeding the target releaser trigger depth of 30m. Each test was observed underwater using a camera (Tests A1, A2 & B1: GoPro 7; and all other tests: GoPro 5) paired with a Star-Oddi Starmon TD sensor (depth & temperature; D-0145), to determine when and at what depth the release occurred. A Marport depth sensor was also attached to the pump-head to give real-time depth readings during all tests (except test A1).

Test A1: 24th March 2022. The releaser and securing chain were fitted to the pump, without the cod-end skirt attached (figures 7.2 & 7.3a). The assembly was deployed to a maximum depth of 41.1m but failed to release. It was suspected that there was insufficient force on the locking jaw of the releaser to open it.

Test B1: this was the first trial with the cod-end skirt attached to the pump using the releaser and securing line/rig (figure 7.2a, rig 1; & 7.3b). The assembly was deployed to a maximum depth of 46.0m and again released, but the time and depth of release were unknown because the GoPro 7 camera fitted to the pump-head failed to record.

Test C3: In this test, the securing chain was completely replaced with a doubled length of Dynaema twine, with a shackle at one end forming a hard-eye for inserting into the releaser jaw (figure 7.2d). It was conducted at the end of a test-haul 02. After the test-haul, the cod-skirt was attached to the pump-head, as would be done during normal fishing operations (see above). The pump-head was deployed to a maximum depth of 41.9m but unfortunately the releaser failed to open (table 7.1). When the pump-releaser assembly was recovered and examined, it was observed that the releaser jaw had not fully opened, with the releaser arm partially up. Detailed mechanical examination of the releaser unit provided no explanation for this failure, and again it was presumed there was insufficient force to open the releaser jaw fully.

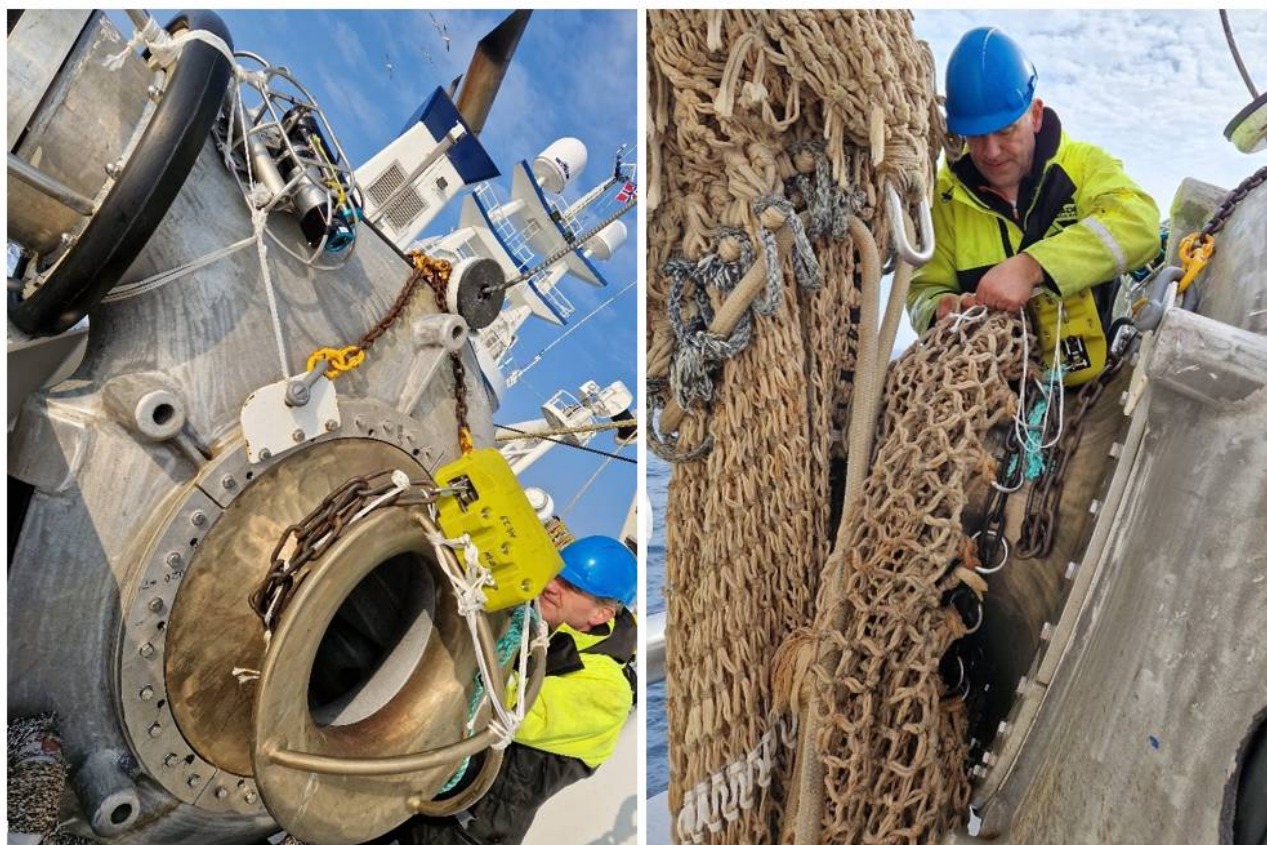
Figure 7.3 – Left: releaser and securing chain (Rig A) attached to pump-head, without the cod-end skirt attached. Camera and depth-sensor array is in a protective steel frame at the top of the image. Right: releaser and securing chain (Rig A) with the cod-end skirt fitted to the pump-head, showing the release jaw side of the releaser.
