CATCH CONTROL IN THE BLUE WHITING PELAGIC TRAWL FISHERY

Research Cruise Report [2022825]: FV "Vikingbank"

TOKTRAPPORT
No.1 2023

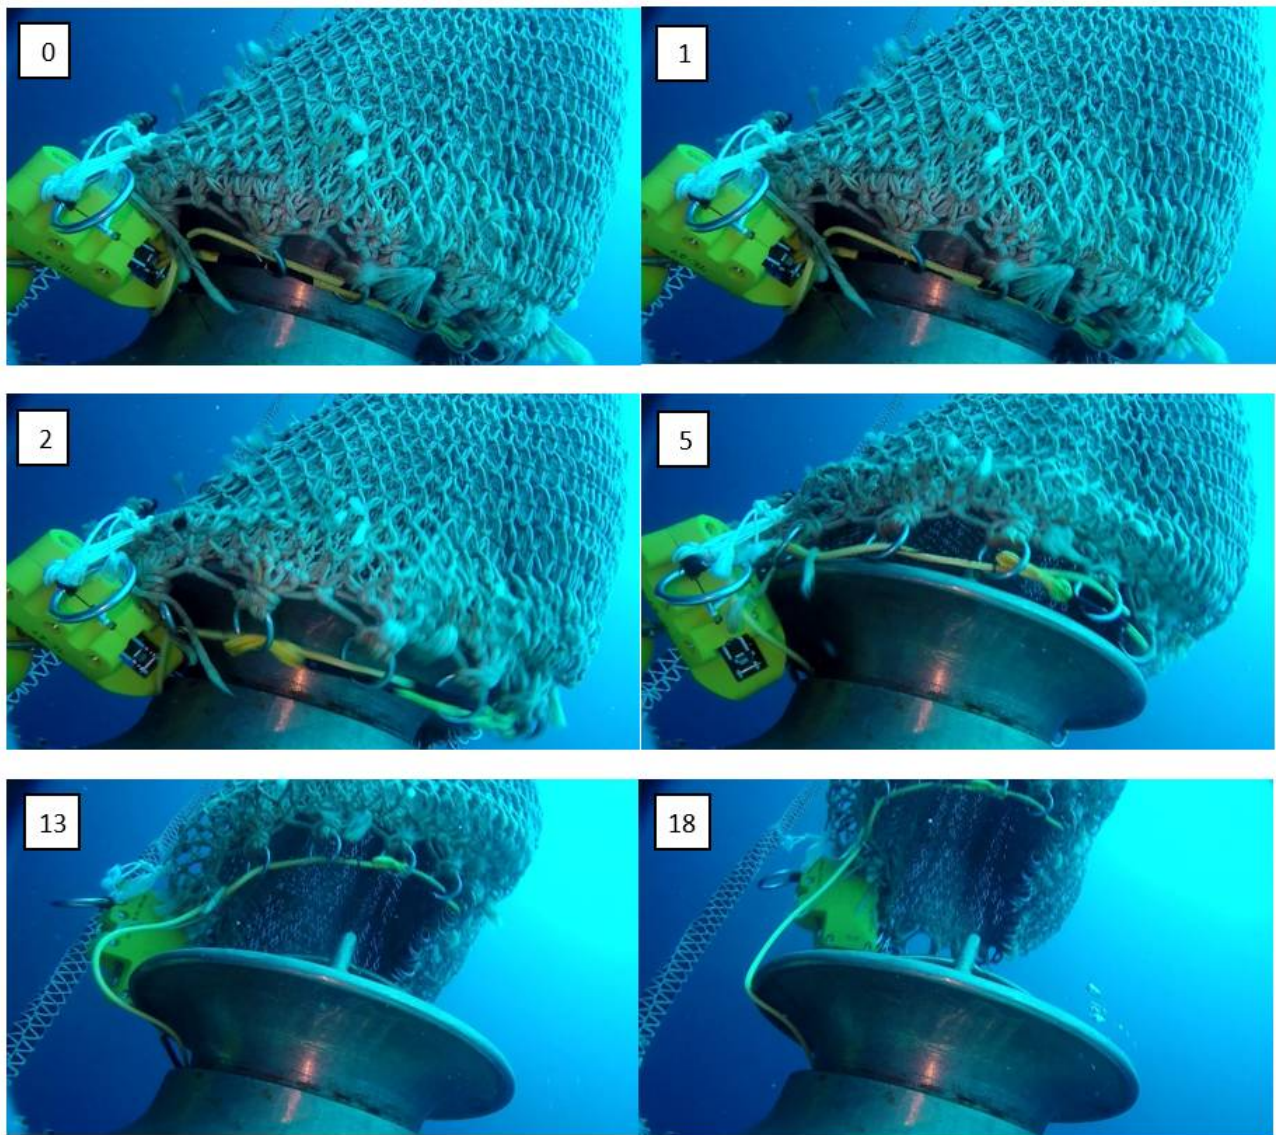
Figure 7.4 – sequence of frames from video (at 24 fps) of the release of the cod-end skirt from the pump head during test C1 (rig 2). Frame 0: just before release; Frame 1: as the releaser jaw opens; Frame 2: securing line leaves the releaser jaw; Frame 5: the cod-end skirt begins to clear the pump-head; Frame 13: ½ sec after release started, the cod-end skirt is mostly clear of the pump-head; and Frame 18: ¾ sec after release started, the cod-end skirt completely clear of the pump-head.

Test C1: 25th March 2022. Changed to releaser #2, because #1 had a poor blue-tooth connection during setup. To enable the end of the securing line that was fixed in the releaser jaw to pass more easily through the rings of the cod-end skirt, the rope with a shackle at the end (figure 7.2b; rig 1a) was replaced with Dynaema twine with a soft eye secured into the releaser jaw (figure 7.2c; rig 2). This appeared to work well on its first test, with the releaser opening at 09:41:29 (20.93m) during its ascent from a maximum depth of 43.0m (table 7.1). Note, the cod-end skirt was clear of the pump-head in <1 second (figure 7.4).

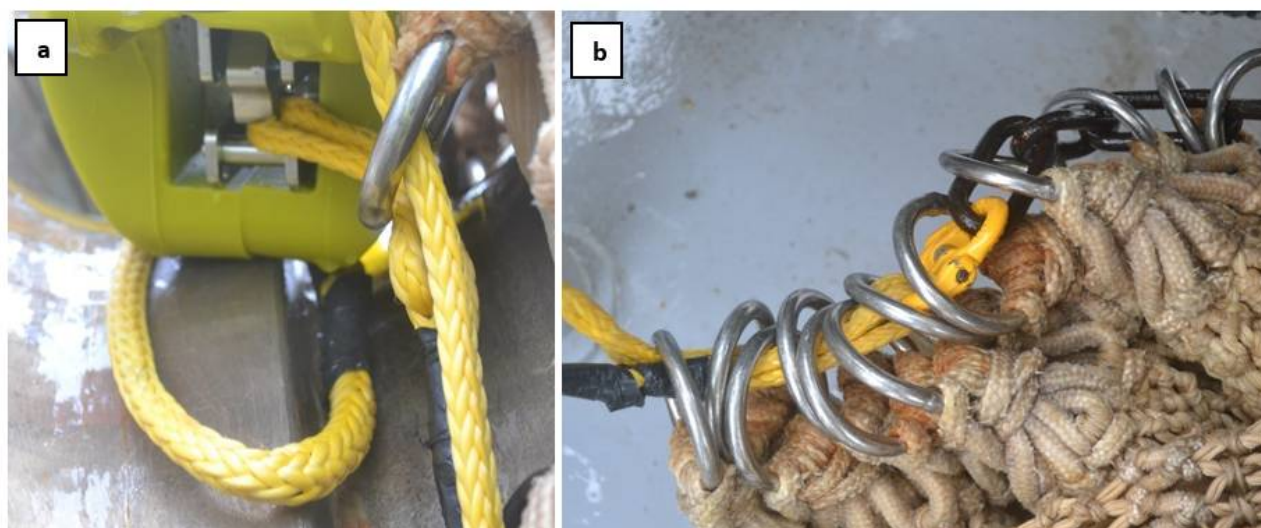
Figure 7.5 – Observations after test C-2 (rig 2); a: the soft eye was only partially released from the releaser jaw; and b: the hammerlock linking the Dynaema twine to the securing chain was jammed in the cod-end skirt rings.

Test C2: this was a repeat trial with the same rig as test C1 (rig 2). The pump-head was deployed to a maximum depth of 42.3m but unfortunately the releaser failed to open (table 7.1). When the pump-releaser assembly was recovered and examined, it was observed that the soft eye was partially released from the releaser jaw (figure 7.5a). Moreover, the hammerlock linking the Dynaema twine to the securing chain was jammed in one of the rings around the cod-end skirt (figure 7.5b). In combination, these observations suggest that, because the securing line was not free to pass through the rings, there was insufficient force to fully open the releaser jaw when it was triggered to release. It was also suspected that the soft-eye in the Dynaema may have contributed to this lack of force by being to slip partially out of the releaser jaw.

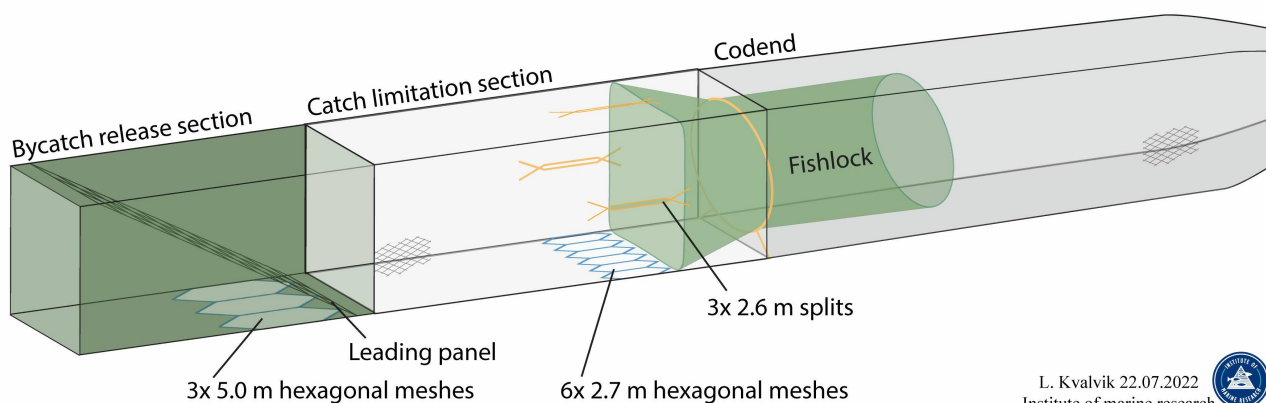
Figure 8.1 - Bycatch Release Section (BRS) was fitted immediately forward of the Fish Release Section (FRS) of the Catch Limitation System (CLS).

The Bycatch Release Section (BRS) was fitted immediately forward of the Fish Release Section (FRS) of the Catch Limitation System (figure 8.1). It consisted of a 12.0m long four-panel cylindrical section of 80mm diamond mesh netting, in the bottom panel of which were cut three 5.0m long hexagonal escape openings (figure 8.2a). Inside the FRS was an 11.2 long diagonal leading panel of 600mm (300 by 300mm) square mesh netting, set at an angle of approximately 16° (figure 8.2a). The BRS was fitted to the trawl during four hauls (table 2.1). Test hauls 1 and 2 were used to make video and trawl sonar observations of the FRS and BRS sections, to ensure they were fitted correctly. Haul 01 was the first behavioural observations with a live catch. Based on these observations modifications were made to the BRS, by cutting away a 1.2 by 2.7 m opening at the top end of the leading panel (figure 8.2b). This version was tested in haul 07.

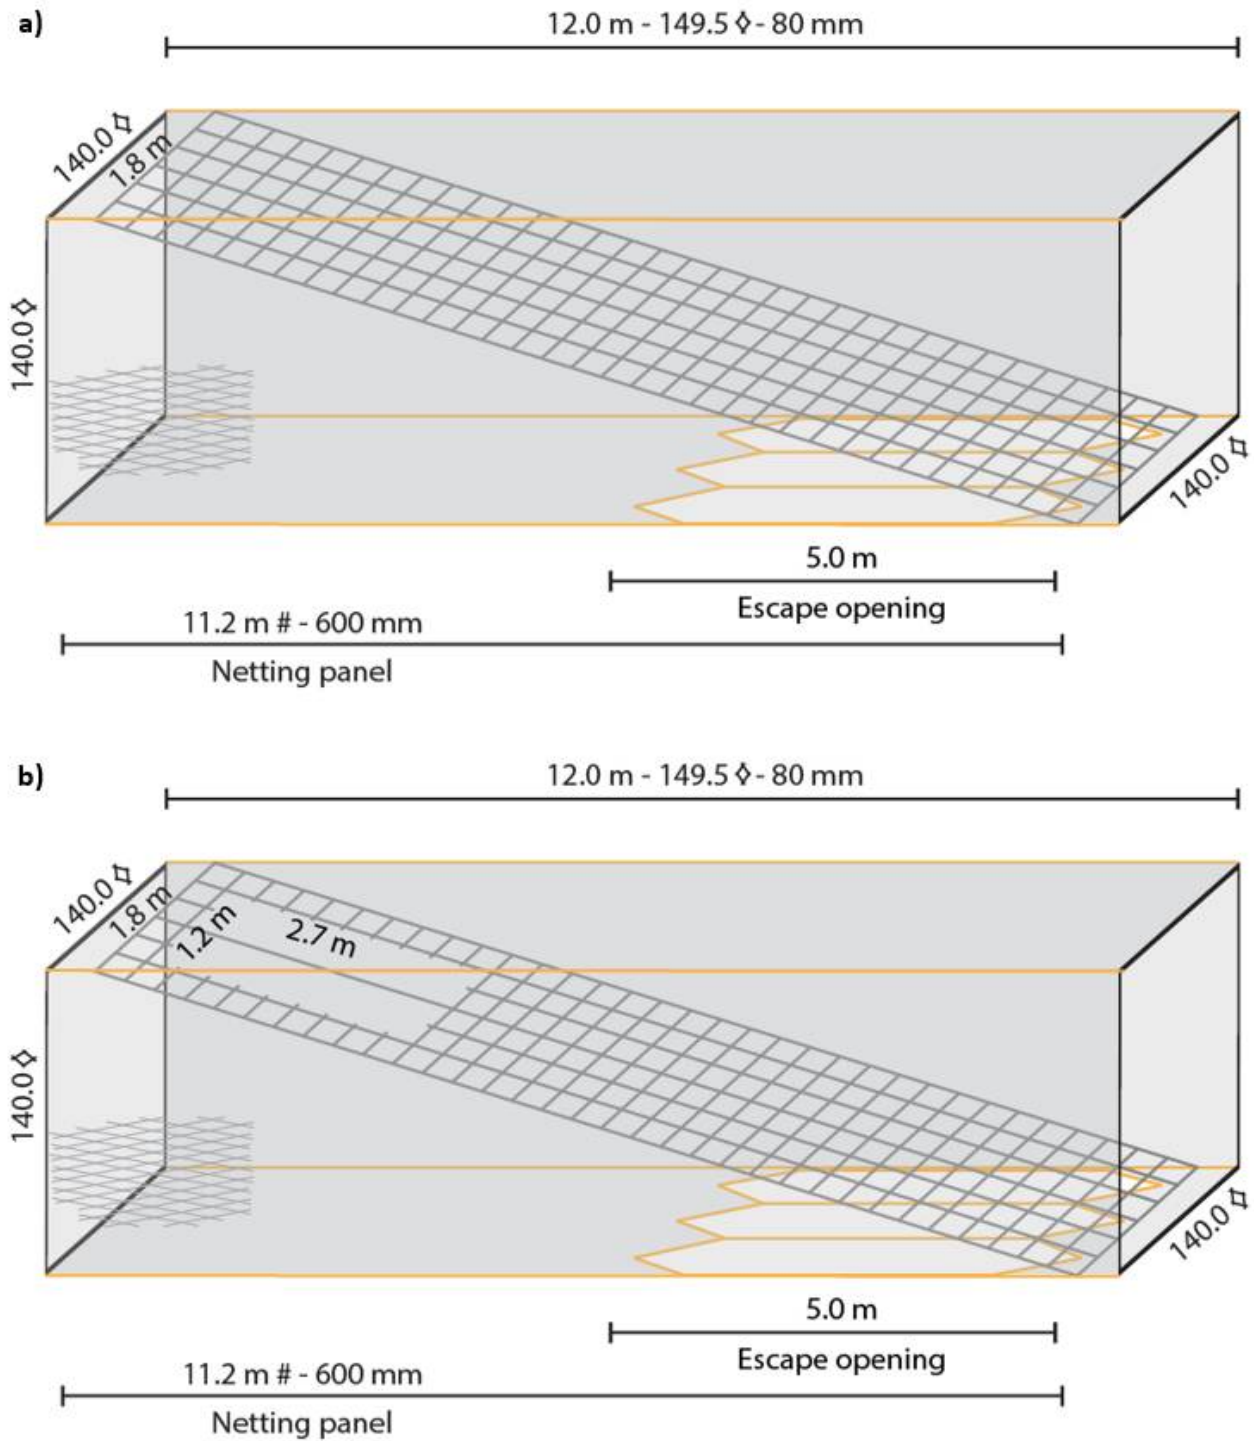
Figure 8.2 – Schematic drawings (not to scale) of the Bycatch Release Section (BRS): a) version 1 used in Test Hauls T1 & T2 and Haul 01; and b) version 2, with a hole cut in the leading panel, used in Haul 07.

Haul 01 demonstrated that a substantial proportion of blue whiting encountering the leading panel in the BRS was exiting via the escape openings (figures 8.4 & 8.5). Although the mesh openings in the leading panel were relatively large (300 by 300mm square), at the shallow angle (~16o) they were presented to the fish approaching the leading panel they would have had a projected vertical opening of only ~63mm. Based on this and the knowledge that blue whiting entering the cod-end tend to accumulate higher up, while the porbeagle observed in cruise 1 swam along the bottom of the cod-end (Breen et al, 2021), it was decided to cut a hole in the upper part of leading panel in an attempt to reduce the excessive loss of blue whiting from the BRS (figure 8.2b).

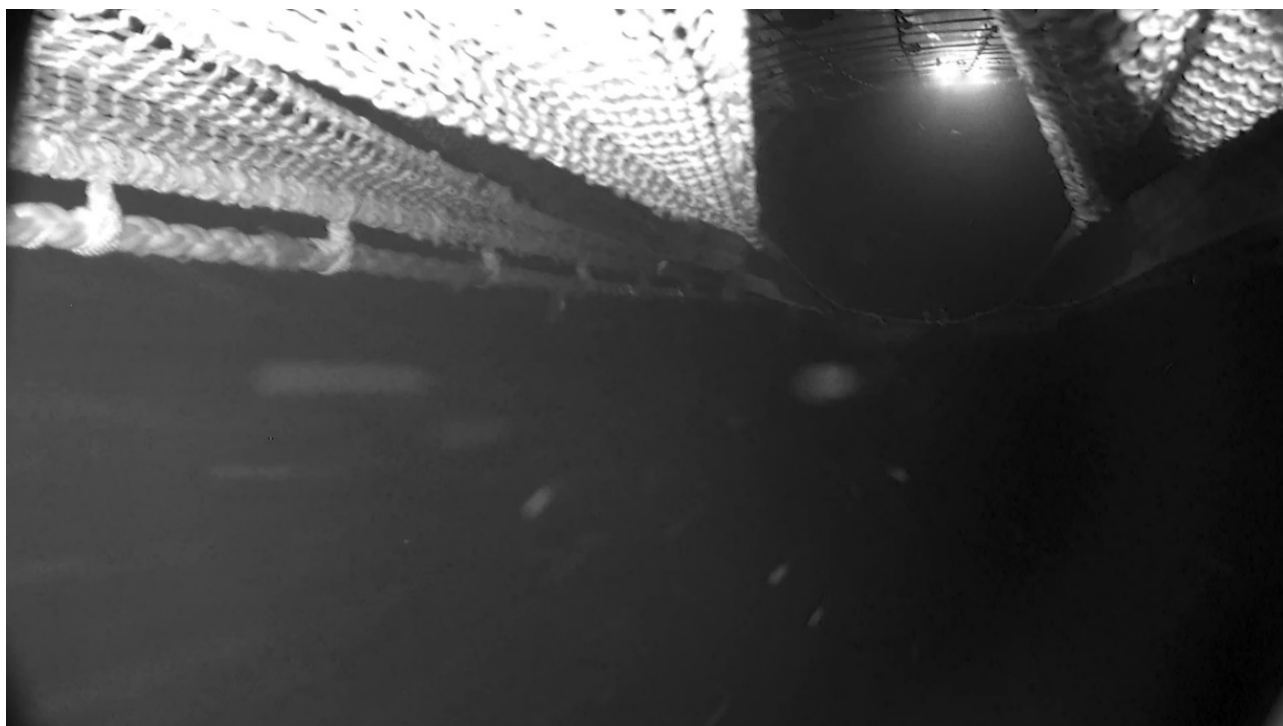
Figure 8.3 – view from camera position 6oF, showing the leading panel visible through the escape openings of the BRS.

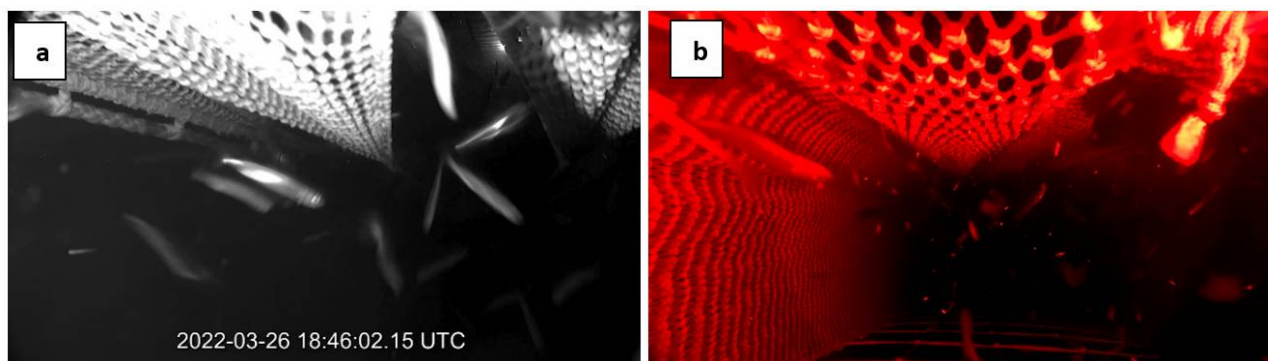
Figure 8.4 – images from video early in haul 01 [18:46:02]: a) position 6oF, below the BRS escape opening, shows a substantial number of blue whiting escaping; while b) position 9iB, inside the BRS aft of the leading panel, shows few blue whiting passing through panel. For comparison, at this same time, escapes from the bottom opening in the FRS were only 7 fish per minute, but it was difficult to differentiate between fish exiting via the BRS and FRS, so this estimate could be less (position 2oF, not shown).

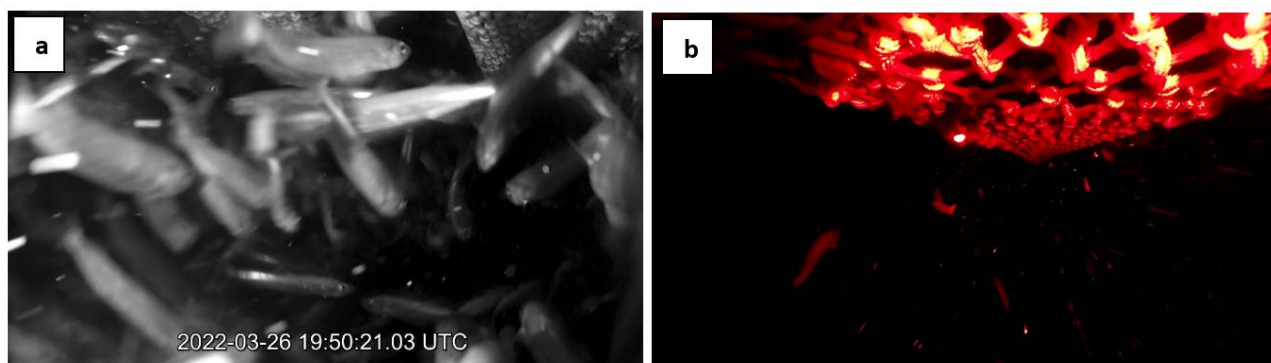
Figure 8.5 – images from video later in haul 01 at higher catch densities [19:50:21]: a) position 6oF, below the BRS escape opening, shows a very substantial number of blue whiting escaping; while b) position 2oF, outside the bottom opening in the FRS, shows fewer blue whiting escapes. For comparison, the escape rate from the bottom opening in the FRS (position 2oF) at this time was approximately 30 fish per minute, but it was difficult to differentiate between fish exiting via the BRS and FRS, so this estimate could be less. Unfortunately, there was no video available inside the BRS at this time, because the camera at position 9iB stop recording at 18:46:10.

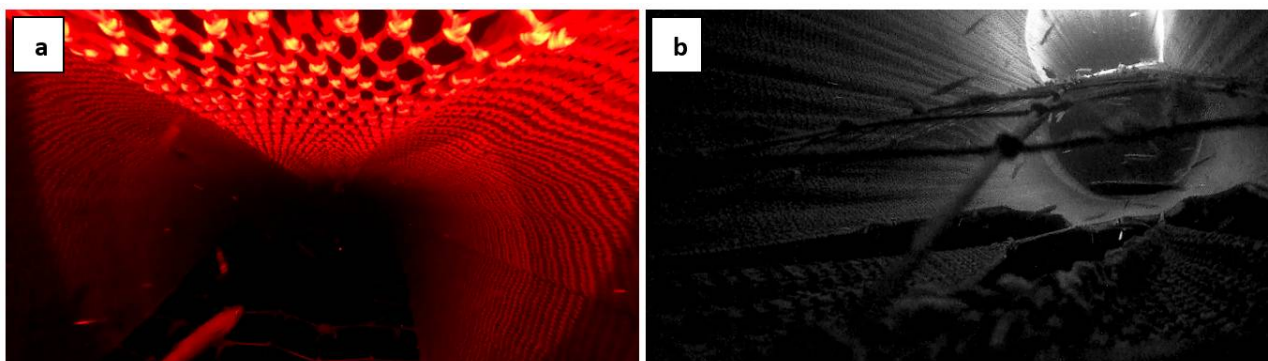
Figure 8.6 - images from video inside the BRS early in haul 07 [03:10:47]: a) position 7iF, looking forward towards hole in leading panel; b) position 6iF (DarkVision camera), looking forward from behind the leading panel, with escape holes in bottom panel visible in the foreground. DarkVision camera operating without its own light during this period.

Version 2 of the BRS, with the hole in the leading panel, was tested in haul 07. Video from the camera in position 7iF showed that there was a steady passage of fish through the opening in the leading panel (figures 8.6a-8.10a). However, from the available video of the escape opening (at position 6iF), it was not clear whether this modification had effectively reduced escape rates, because the view of the opening was often obscured during periods of high fish density. Although, it was clear at low and moderate fish densities, that fish were being guided into the lower half of BRS and towards the escape openings, with frequent escapes (figures 8.6b, 8.7b & 8.10b). At higher fish densities, sufficient numbers of fish were deflected by the panel onto the lower panel behind the escape openings to cause a blockage (figure 8.8b & 8.9b), presumably resulting in substantial escapes of fish ahead of the blockage. During their passage through the netting of the leading panel, most fish contacted the netting with sufficient force to cause the netting panel to deform at higher fish densities (e.g. figure 8.8b).

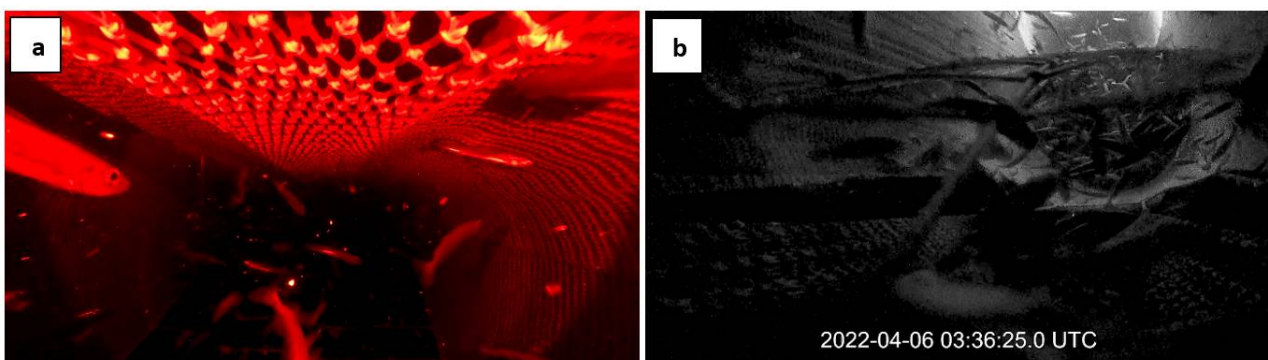
Figure 8.7 - images from video inside the BRS early in haul 07 [03:36:25]: a) position 7iF, hole in leading panel allowing fish through in upper part of BRS; b) position 6iF (DarkVision camera), moderate fish density in front of panel with some fish passing through the lower panel, while a substantial proportion is deflected down and out of the escape openings. DarkVision camera operating without its own light during this period.

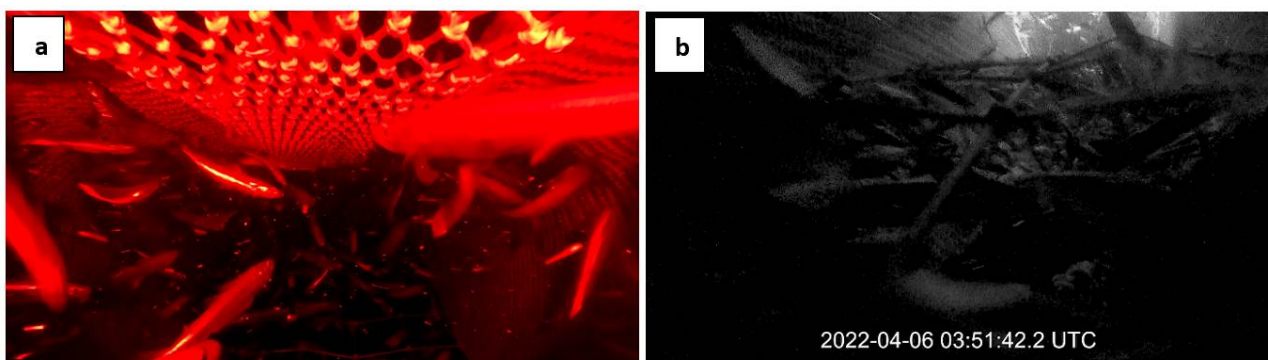
Figure 8.8 - images from video inside the BRS early in haul 07 [03:51:42]: a) position 7iF, hole in leading panel allowing fish through in upper BRS; b) position 6iF, in contrast at higher fish densities the deflection of fish down the leading panel causes a blockage. DarkVision camera operating without its own light during this period.

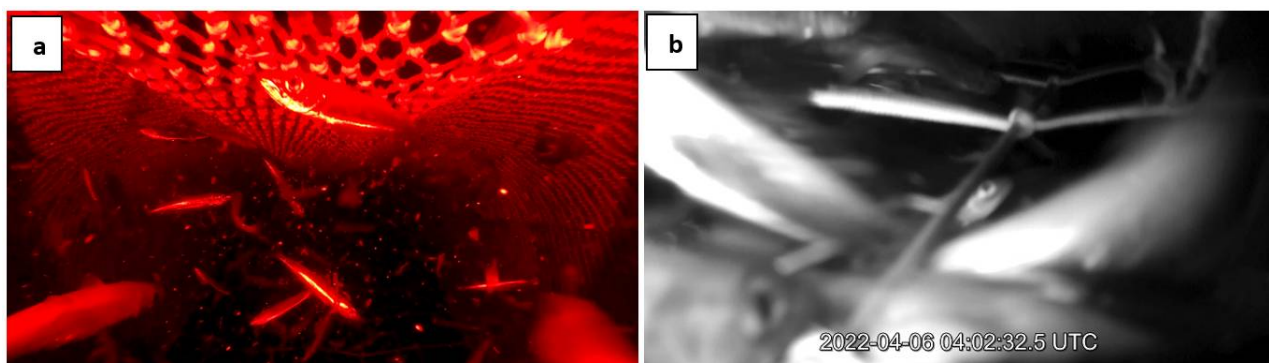
Figure 8.9 - images from video inside the BRS early in haul 07 [04:02:32]: a) position 7iF, hole in leading panel allowing fish through in upper BRS; b) position 6iF, in contrast at higher fish densities the deflection of fish down the leading panel causes a blockage. DarkVision camera operating without its own light during this period.

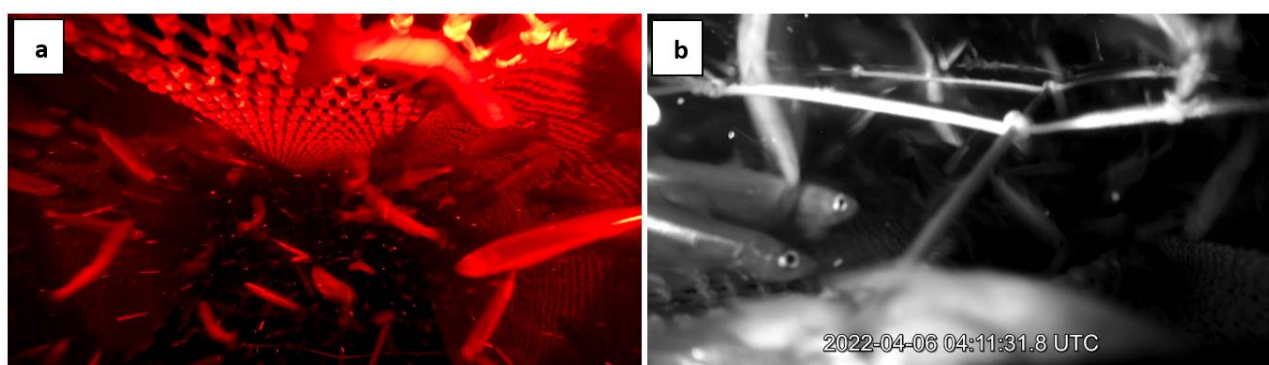
Figure 8.10 - images from video inside the BRS early in haul 07 [04:11:31]: a) position 7iF, hole in leading panel allowing fish through in upper BRS; b) position 6iF, moderately high fish density in front of panel with some fish passing through and frequently contacting the panel, while a substantial proportion is deflected down and out of the escape openings.

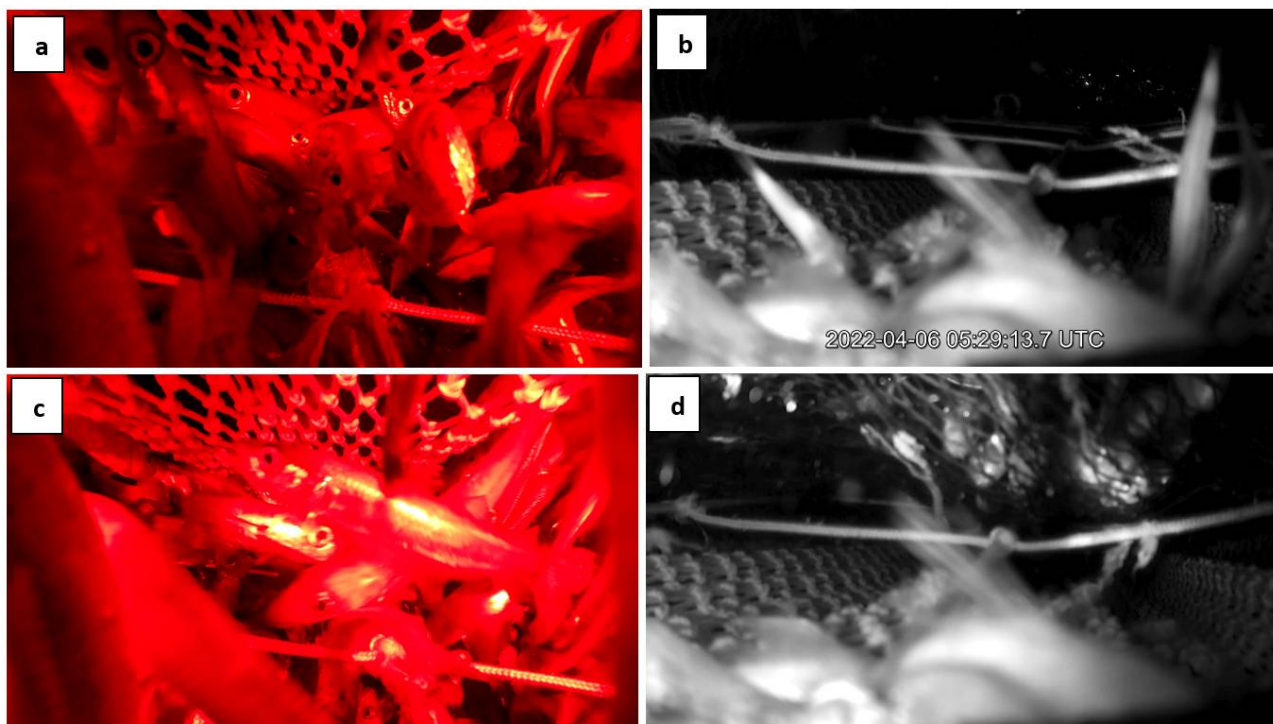
Figure 8.11 - images from video inside the BRS during hauling haul 07 [05:29:13]: a) position 7iF [05:29:13], fish accumulating at top of the leading panel; b) position 6iF [05:29:13], accumulation of fish at the top of the leading panel visible as speckles in the background; c) position 7iF [05:29:21], fish accumulating at top of the leading panel; and d) position 6iF [05:29:21], mass of fish trapped in netting behind the leading panel.

At the end of haul 07, during hauling, there was an unexplained crowding event observed by camera positions 6iF and 7iF (figure 8.11). At 05:29, there was an accumulation of fish ahead of the upper part of the leading panel in the BRS (figure 8.11a & b). At this time there was a reduced water flow in the trawl, and it is assumed that these fish had been ahead of BRS at the end of the fishing tow. Within less than 30 seconds the view at camera position 6iF was obstructed by a mass of fish trapped inside a netting fold. It is unclear what part of the trawl is forming this netting fold, but it is thought unlikely to be the fish lock in the CLS (which did invert during this haul; see section 4) because this was 16m aft of this position, and the fish-lock netting panel has a maximum length of 11.64m. This type of event was not observed in haul 01.

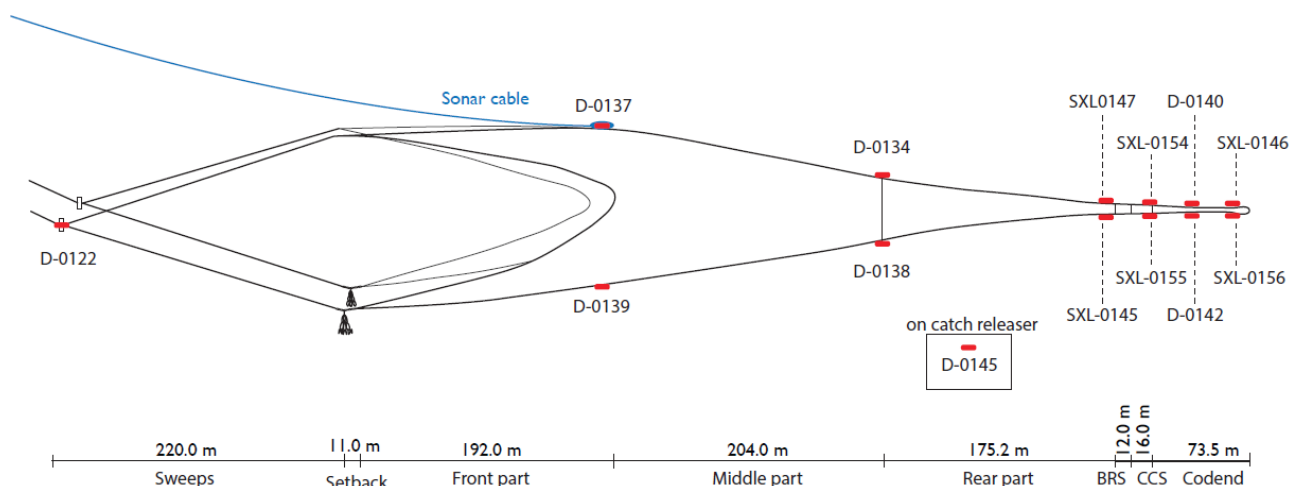
Figure 9.1 - Positions and Identity Code for depth sensors on the trawl. Detailed positions for the cod-end depth sensors are detailed in table 9.1. [Source: Liz Kvalvik].

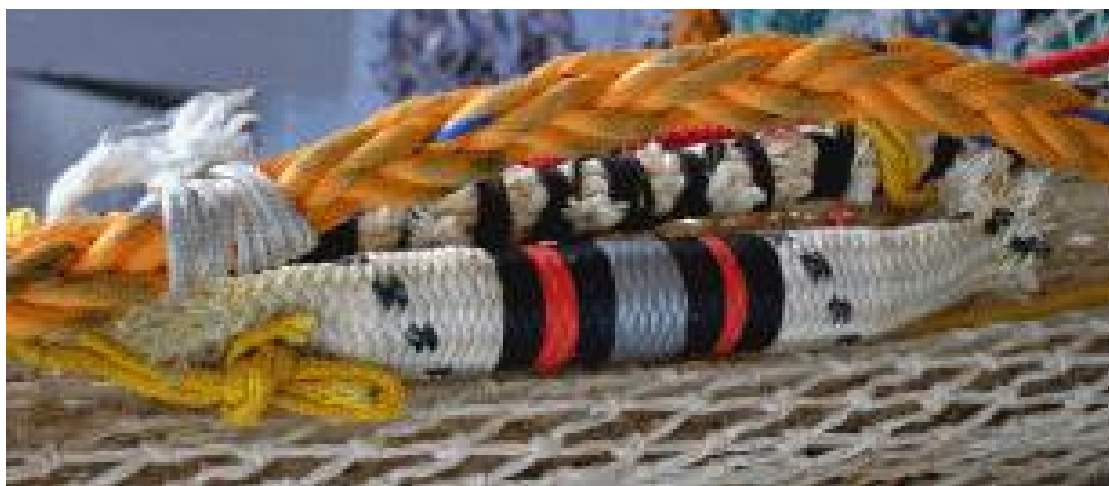
Figure 9.2 – a depth sensor (SXL-0154) in its protective housing and sheath fixed to the top of the FRS.

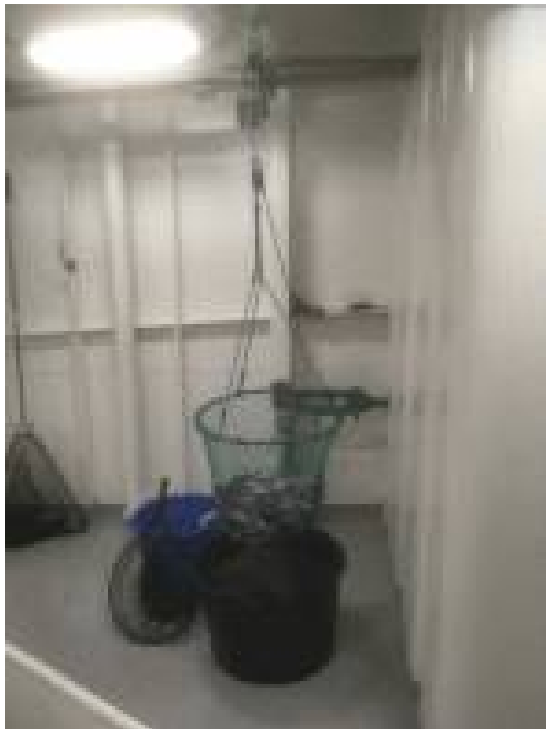
Figure 10.1 – Rig for weighing fish samples in air and in seawater, with the fish held in a net bag supporting by a steel ring.

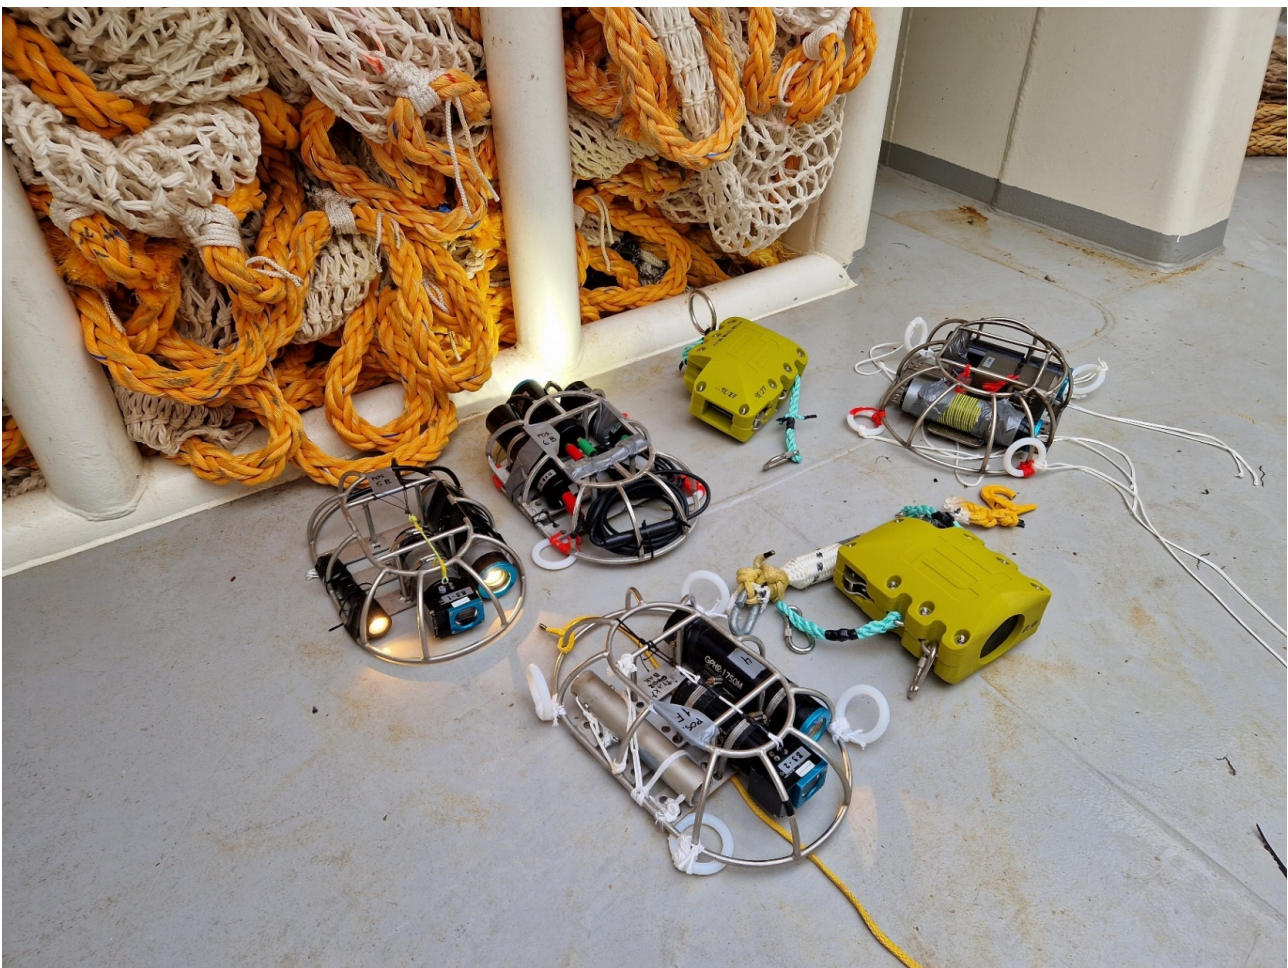
Figure A1 – various camera systems and other instruments ready for deployment before Test haul #T2: top left, GoPro cameras (in a B-group housing) in a protective steel “dome-frame”, with two white lights; top centre a FossTech Codend Choker Unit (CCU); top right, the “DarkVision” camera system in a “dome-frame”; centre right, a removal depth sensor and backup CCU; and bottom centre, a GoPro Hero 5 (in a B-group housing) in a “dome-frame”, with one white light and a depth sensor, for monitoring the CCU opening time and depth.
